Preventable Coating Defects

Author: Raed El Sarraf
Affiliation: New Zealand Heavy Engineering Research Assn Inc.
Date: 1st May 2008
Ref.: CTG1003

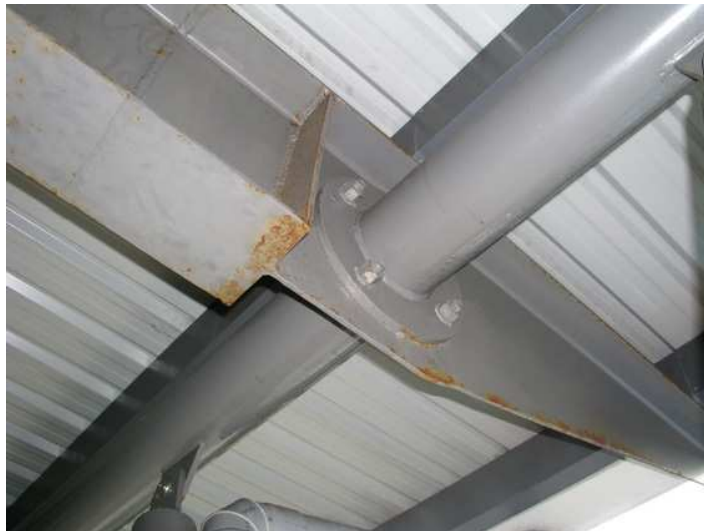
Figure 1 show two fully coated CHS members bolted on to a primed only main girder holding a canopy. Half of the main girder is inside the building with the other half outside the building exposed to the prevailing wind. The exposed part of the girder should have been coated in a manner similar to the attached CHS members; however, the coating used on the internally exposed portion was used, a simple alkyd primer on wire brushed surface. A suggested coating for the exposed portion of the girder would be a 3 coat system of a zinc rich primer, followed by a high build epoxy, finished with a poly-urethane gloss coating (designated as PUR5 in Table 6.3 of AS/NZS2312) to a surface preparation of Sa2 1/2. Note the accelerated corrosion and the dull finish the main girder has in comparison to the appropriately coated bright and better performing CHS.

Figure 1: Exposed Girder and CHS

Better communication between the architect, engineer, builder, fabricator and coatings applicator could have avoided this.

Where two coatings systems are to be used on a member the extent of each coating and type needs to be clearly specified.

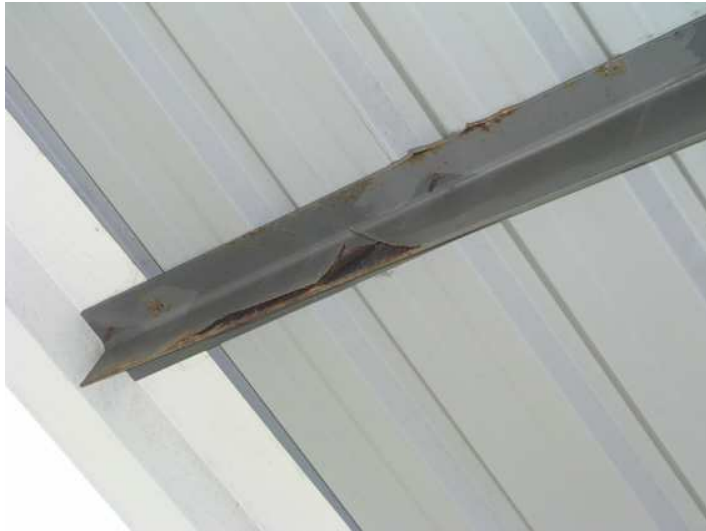
Figure 2 shows a coated T-section lacking a zinc rich primer, which would have prevented coating undercutting that led to delamination. Another contributor to this defect are the rough gas cut edges of the T section as discussed in the following Defect No. 3.

Figure 2: Coating Delamination

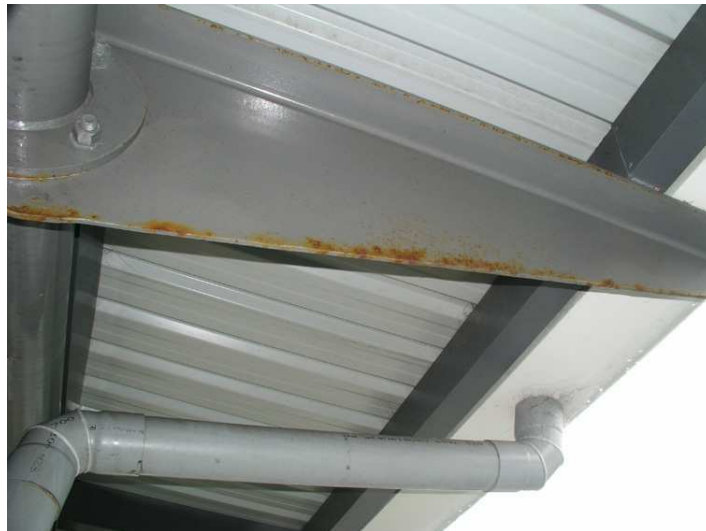
Figure 3 shows corrosion initiating at the girder's edges which are still "sharp". AS/NZS 2312 Figure 3.1 (q) states that all "sharp edges" are to be chamfered or rounded prior to coating to allow sufficient coating build up. An inappropriate coating application to the exposed rafter as discussed in Defect 1 also contributed to the defect.

Figure 3: Sharp Edges Accelerated Corrosion

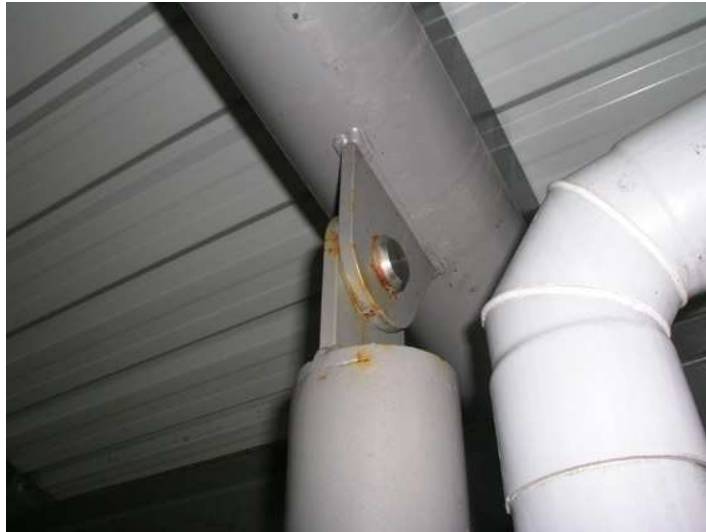
Figure 4 shows a stainless steel pin without a neoprene washer to isolate the stainless steel from the mild steel. The result is accelerated bimetallic corrosion around the pin.

Figure 4: Bimetallic Corrosion
