Imported Fabricated Steelwork: Case Study #2

# Establishing the traceability of imported steel

### Warehouse, Auckland

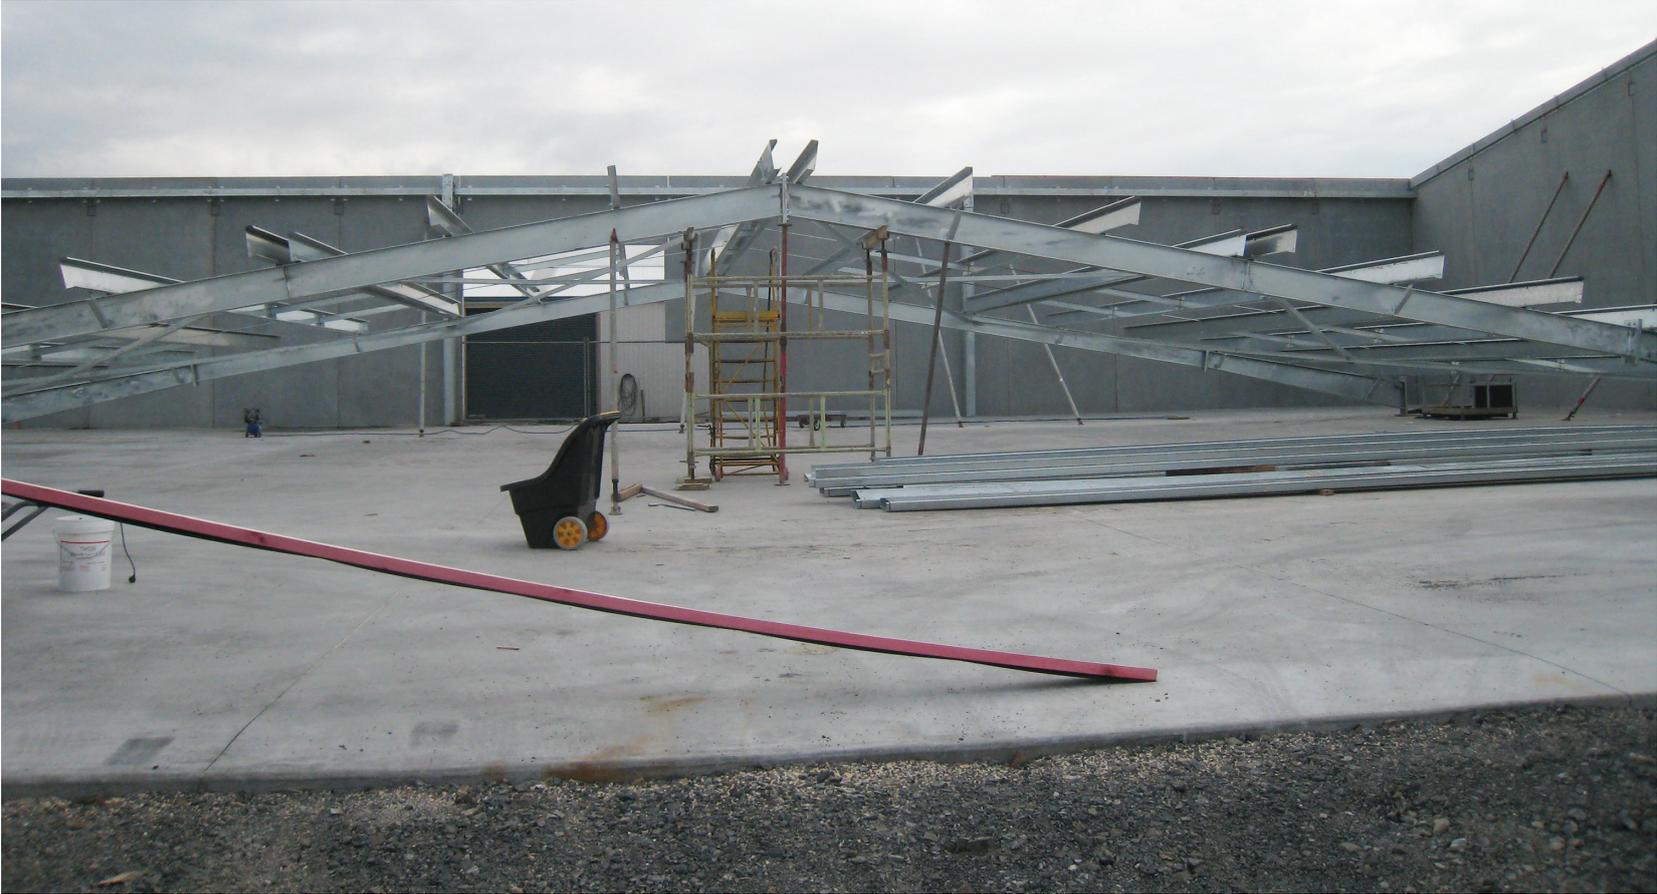
This Auckland warehouse was built using portal frame construction. The portals, which span 31m, are set at 13m intervals creating six bays. The portal frames taper from 350mm to 600mm at the knee, which is 6m in height. The portal steel, all of which is galvanised, is made from welded I beams. All the steel was sourced from China.

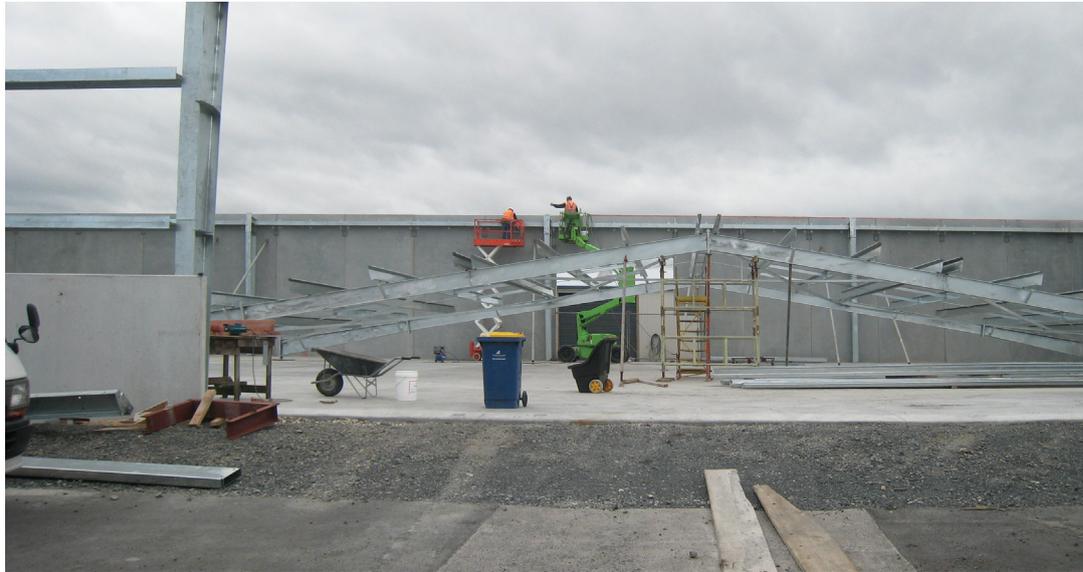
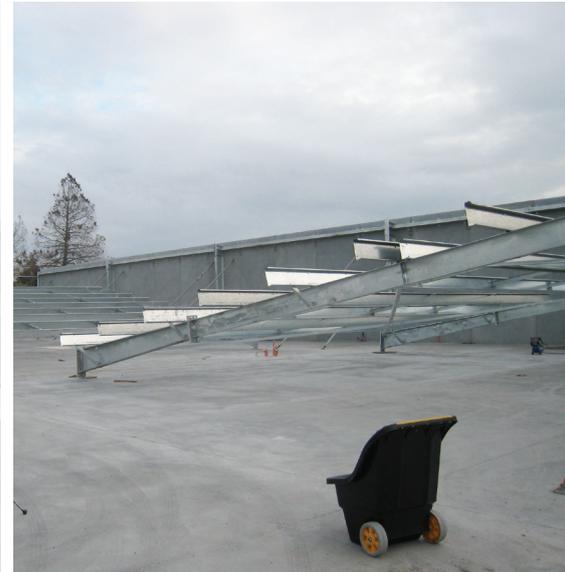
At this point, the portal frames were already on site. Several samples were taken from the fabricated steelwork: purlins, rafters, columns, bolts and welds.

As credible evidence of compliance could not be provided for the portal frames, Q Designz (engineering consultants to Auckland Council), in consultation with SCNZ, recommended a series of testing procedures be carried out by an ILAC-accredited test laboratory in New Zealand.

After more than two months of local testing to determine the strength, ductility and weld quality, which delayed progress on the project, the Council agreed there was sufficient information to satisfy it that the fabricated materials were compliant.
