FIRE PERFORMANCE OF LSF WALLS MADE OF HOLLOW FLANGE SECTION STUDS

S. Kesawan¹ and M. Mahendran²

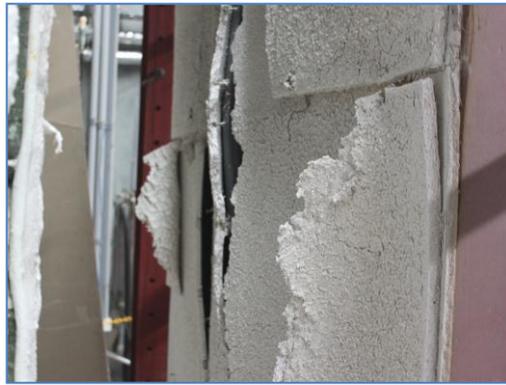
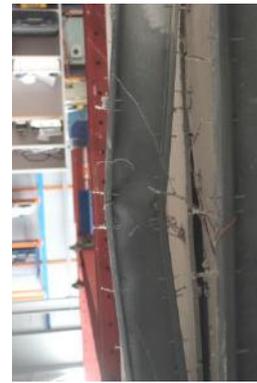
Figure 9. Failure of wall specimen in Test 1

In Test 1, the failure occurred after 180 minutes. The wall moved towards the furnace progressively due to the thermal bowing effect, and near the failure point, a very rapid lateral movement of the wall was observed. The failure occurred by flexural torsional buckling of Stud B. The failed wall specimen was carefully inspected the next day. The second (outer-pb1) layer of fireside plasterboards had partially fallen off with the loss in the middle portion. However, at the ends a very small portion of the plasterboards was retained. This was because at the ends the temperature might have been lower than at other places. The second layer of fire side plasterboards had completely calcinated, but the first (inner-pb2) layer of fire side plasterboards stayed intact with the frame. However, a big vertical crack appeared throughout the entire length of the

plasterboards on top of Stud B. It had spread from the bottom track to the top track. At the ends the crack width was very small. However, towards the middle of the wall, the crack width increased. The plasterboard joint on top of Stud C was completely dislodged. Stud B had bent towards the furnace about the major axis and twisted about the minor axis. The compression side of the studs had buckled and yielded. This clearly indicated that Stud B had failed due to flexural torsional buckling. Local buckling waves were clearly present throughout the entire length of Stud B. This shows that Stud B had undergone local buckling prior to flexural torsional buckling failure. Local buckling waves and a small twist about the minor axis were observed in Stud C. The time-temperature profiles of the plasterboard surfaces and hollow flange section studs are given in Figs. 7 and 8. The interface symbols in Fig. 7 are defined in Fig. 4. The failure pictures are given in Fig. 9.

(a) Partial fall off of plasterboards

(b) Failed LSB stud
