SLAB COLUMN INTERACTION - SIGNIFICANT OR NOT?

ABSTRACT

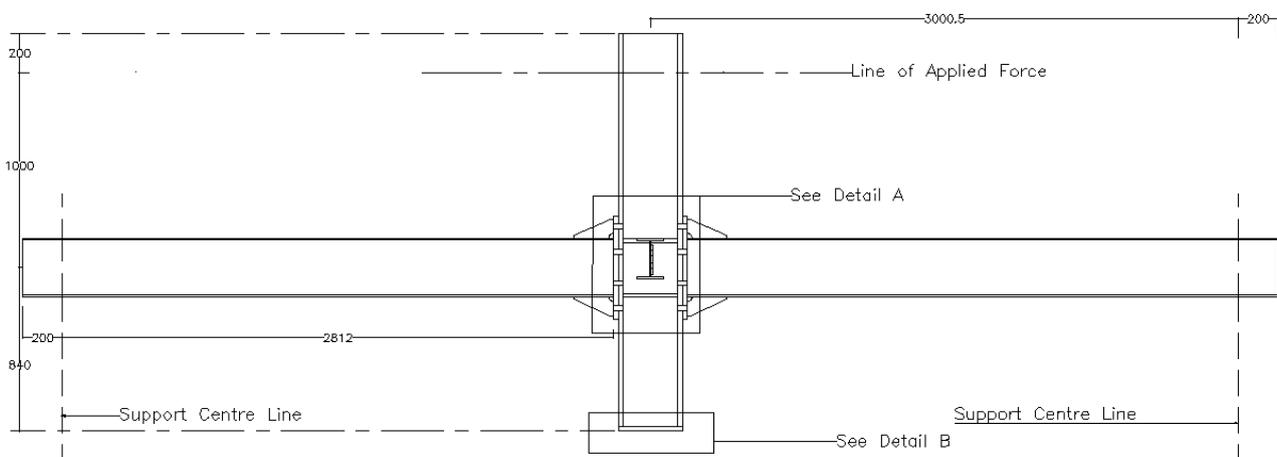
Figure 1: Beam and column setup for all tests.

The physical testing comprised of 5 specimens each of identical beam, column and floor sizes. The specimens comprised of two 3m 310UB32 half beams (to represent a 6m full span) connected to a 2m tall 310UC158 column at mid height as shown in Figure 1. The ends of the half beams were pinned to represent the point of inflection of the full length beam whilst the column was pinned at its base and a ram mount located 2m from the base pin centreline.

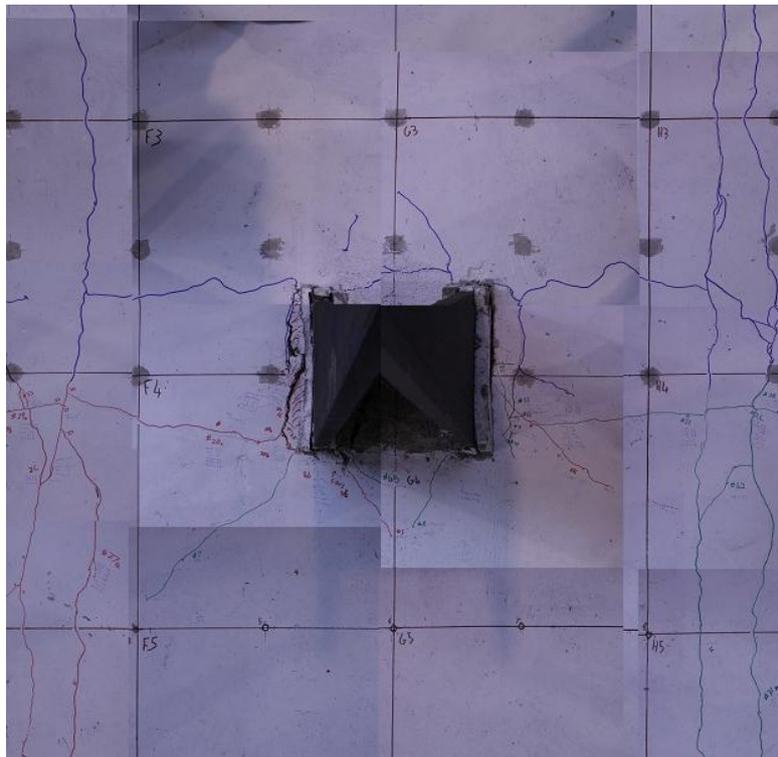
Figure 4: Slab damage in column region after all cycles of test 1.

As shown in Figure 4, damage to the slab surrounding the column was comparatively minimal. Spalling along the east column face was mainly confined to the top 10-20mm of the slab and spalling on the west column face was minimal. The transverse and longitudinal cracks were also comparatively minimal with crack widths rarely exceeding 0.5mm. The largest recorded crack widths were between 1.2 and 1.5mm.

Cracks began to appear from 0.35% drift with initial cracking being confined to transverse cracks running across the width of the slab. These transverse cracks appeared to form beyond 600mm from the column centreline and tended to form over the ridges of the profiled decking, where the slab was shallowest. Further transverse appeared as the testing progressed along with longitudinal cracking in the vicinity of the primary beams. From 3.5% localized spalling and diagonal cracking occurred at the column faces and around the edges of the column flanges.

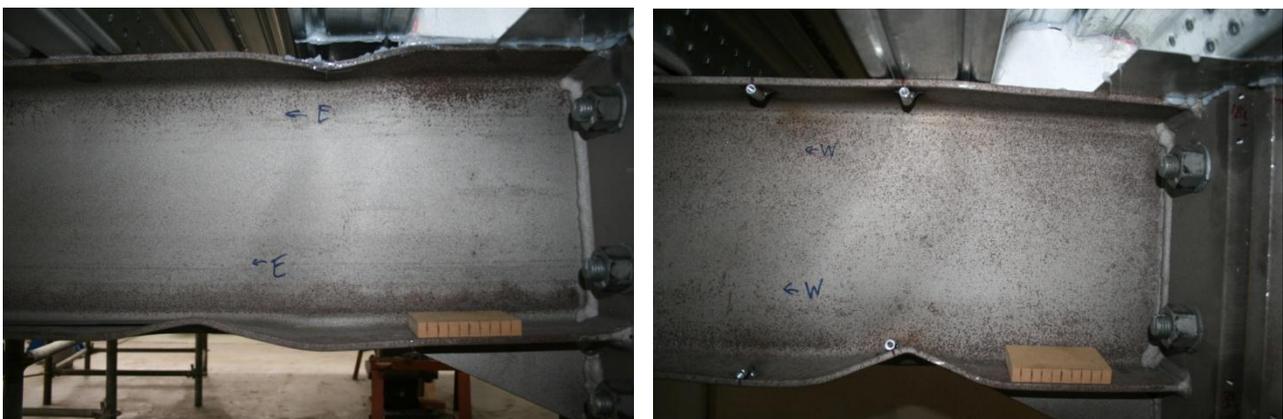
Figure 5: Damage to east (left) and west (right) beams of test 2.

During the first cycles at 2.5% drift, the bottom flanges of both beams began to buckle and continued to do so during the remaining cycles. The buckling of the top flange and the web was more prominent than in the first test as shown in Figure 5.

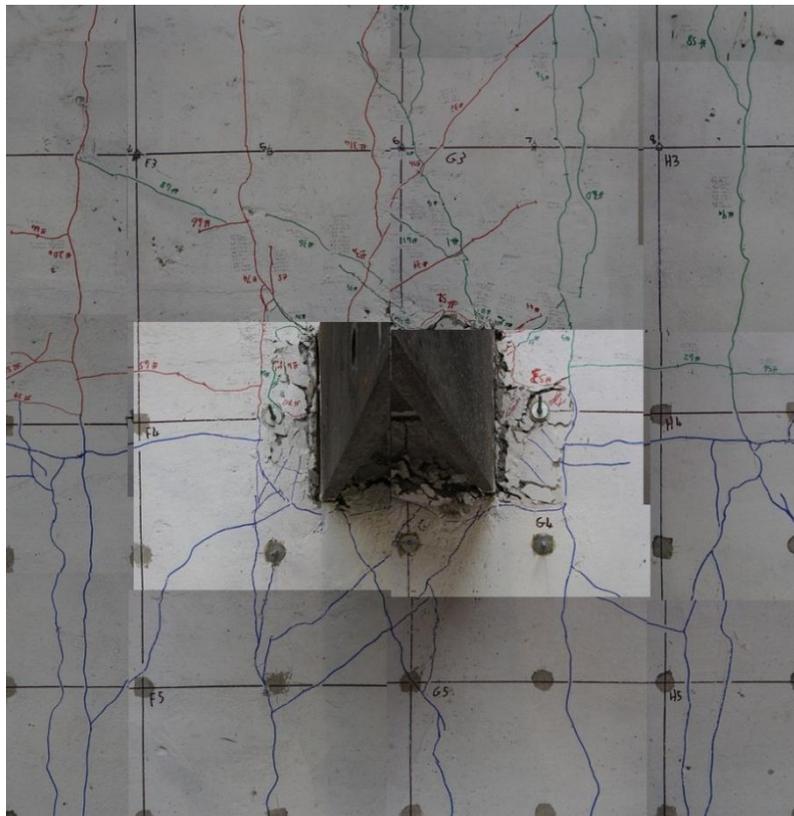
Figure 6: Slab damage in column region after all cycles of test 2.

Damage to the slab surrounding the column is shown in Figure 6. In comparison to the first test, the extent of both the cracking and the spalling at the column faces is significantly greater as is the propagation of the diagonal cracks from the flange tips. The average crack width was also higher than in the first test.

First cracking occurred during the 0.25% drift cycles with diagonal cracks propagating from the edges of the column flanges. This was followed by transverse cracking above the slab ribs and longitudinal cracks along the beam. Unlike the first test, transverse cracks formed above the ribs closest to the column faces and multiple longitudinal cracks were present on both sides of the primary beams. The diagonal cracks from the column flanges propagated 500-600mm into the slab, generally terminating at an intersection with a transverse crack.

Spalling of the concrete in contact with the column faces occurred during the first cycle at 3.5% drift. This was confined to the concrete between the column face and the first rib and was predominately spalling of the concrete above the deck rib. The area of concrete between the column flanges sheared away from the rest of the slab at 3.5% drift and was accompanied by a sudden loss of strength of the overall system. Following the shearing of the concrete between the flanges the vast majority of the remaining cracks on the slab decreased in width to levels closer to those experienced in the previous test with the slab separated from the column.

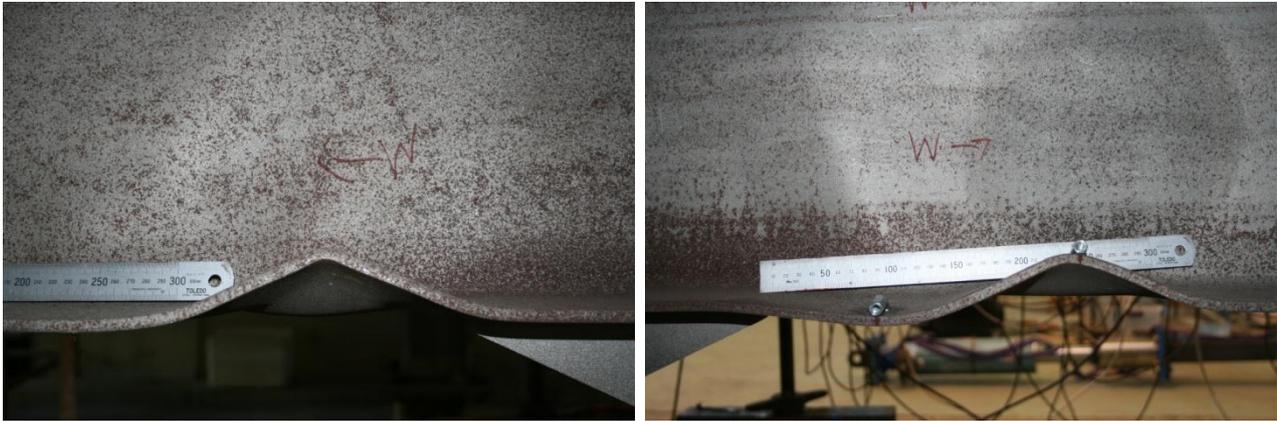
Figure 7: Damage to west beam of specimen 3.

Like the second specimen, testing of the second specimen occurred over 2 days with 0.2%-1.5% drift tested on the first day and 1.5%-5% on the second day. Again the behaviour was elastic to 0.5% drift and beam buckling was observed at 2.5% drift. Concrete spalling was noticed at 2.5% drift and the maximum force applied to the column was 365kN during the first cycle at 2% drift. This equates to a beam-level joint moment of 730kNm. As in the second test the bottom beam flanges began to buckle at 2.5% drift. Again the buckling was more prominent than in the previous two tests with the west beam sustaining significant damage as shown in Figure 7.

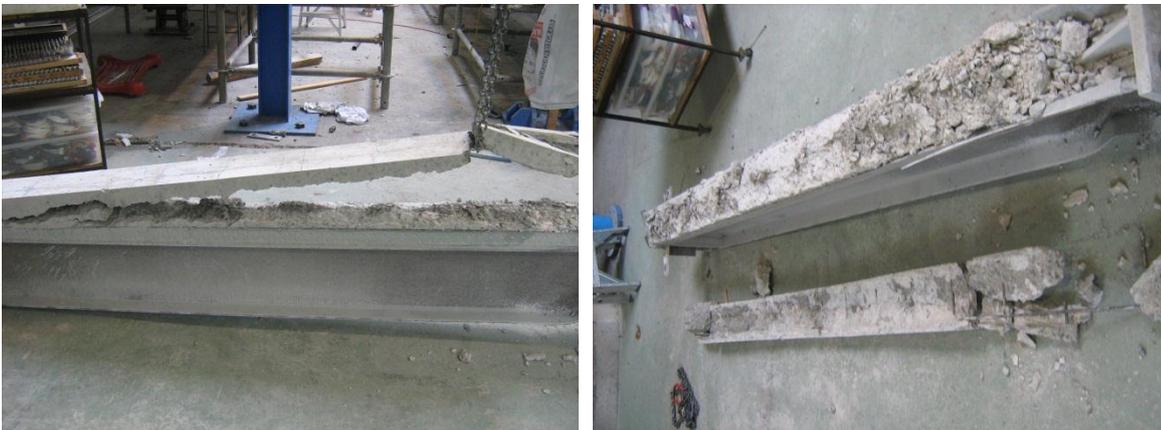
Figure 8: Separation of cover concrete above main beam.

Spalling of the concrete in contact with the column faces began during the 2.5% drift cycles. In the longitudinal direction this was initially confined to the concrete between the column face and the first rib however in the transverse direction the extent of the spalling was more significant extending up to 500mm from the column centreline. Again the area of concrete between the column flanges sheared away from the rest of the slab at 3.5% drift and was accompanied by sudden strength loss. Following completion of the test and removal of the slab beside the beams cracking was noticed approximately 50mm from the top of the slab. Upon closer inspection it was discovered that the top 50mm of concrete above both beams had broken away from the remainder of the slab, as shown in Figure 8.

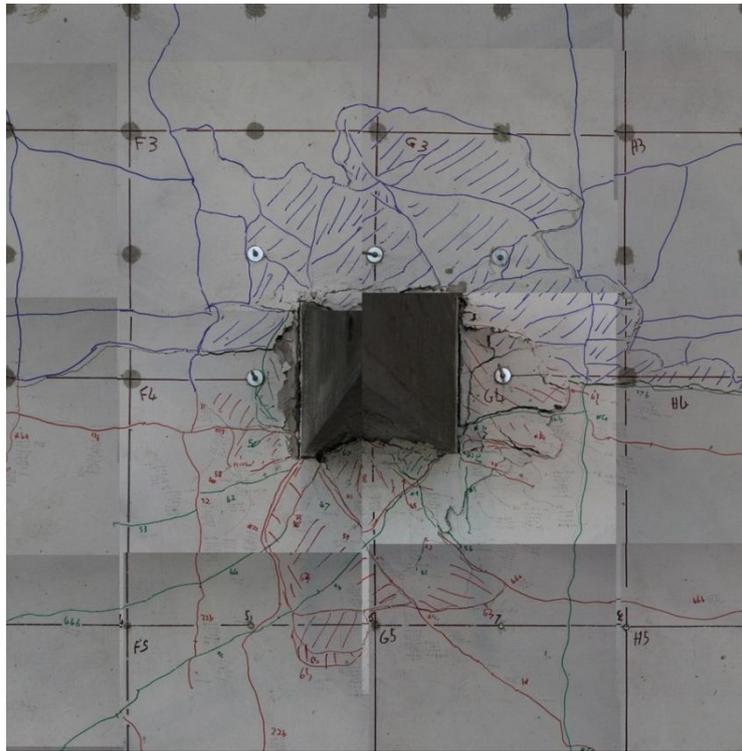
Figure 9: Slab damage in column region after all cycles of test 3.

Damage to the slab surrounding the column is shown in Figure 9. In comparison to the first two tests, the extent of both the cracking and the spalling at the column faces is noticeably higher.

As in the second test, first cracking occurred during the 0.25% drift cycles with diagonal cracks propagating from the edges of the column flanges followed by transverse cracking above the slab ribs as well as longitudinal cracking. The extent of both the longitudinal and diagonal crack patterns was greater than those experienced in the first two tests. Diagonal cracking was observed both at the column and near the ends of the primary beams with multiple cracks at each location. Longitudinal cracks were observed next to the primary beam as well as approximately 500mm from the centreline of the beam. These were roughly centered over the first and second deck ribs either side of the main beams. Average crack widths were higher than in previous tests with multiple cracks exceeding 0.8-0.9mm.

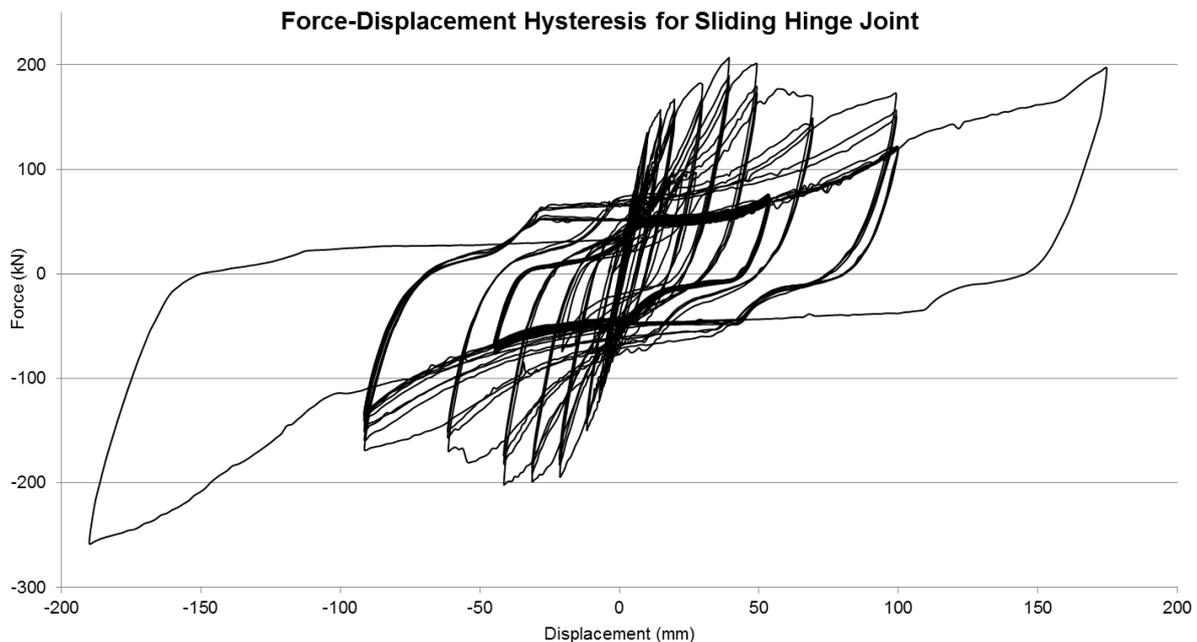
Figure 10: Force-displacement hysteresis for sliding hinge joint.

Following on from this the specimen was put through 50 cycles at 2.5% drift, 7 cycles at 5% drift and 1 cycle at 10% drift (although the ram ran out of travel at +8.5% drift). At these higher drifts a further 2 web plate bolts sheared off and some deformation was noticed in the flange plates of the sliding hinge joint and the bottom flange of the beam. As shown in Figure 10, despite a drop in strength from the first stage of testing, the connection still provided a very stable hysteresis loop during the second stage of testing.

The first part of the testing was to put the sliding hinge joint through the displacement protocol applied to the other specimens. The connection came through this well with the only visible damage being the shearing of one web plate bolt at 5% drift due to vertical displacement incompatibility. As in the third test, the slab spalled at 3.5% drift with a corresponding loss of strength.

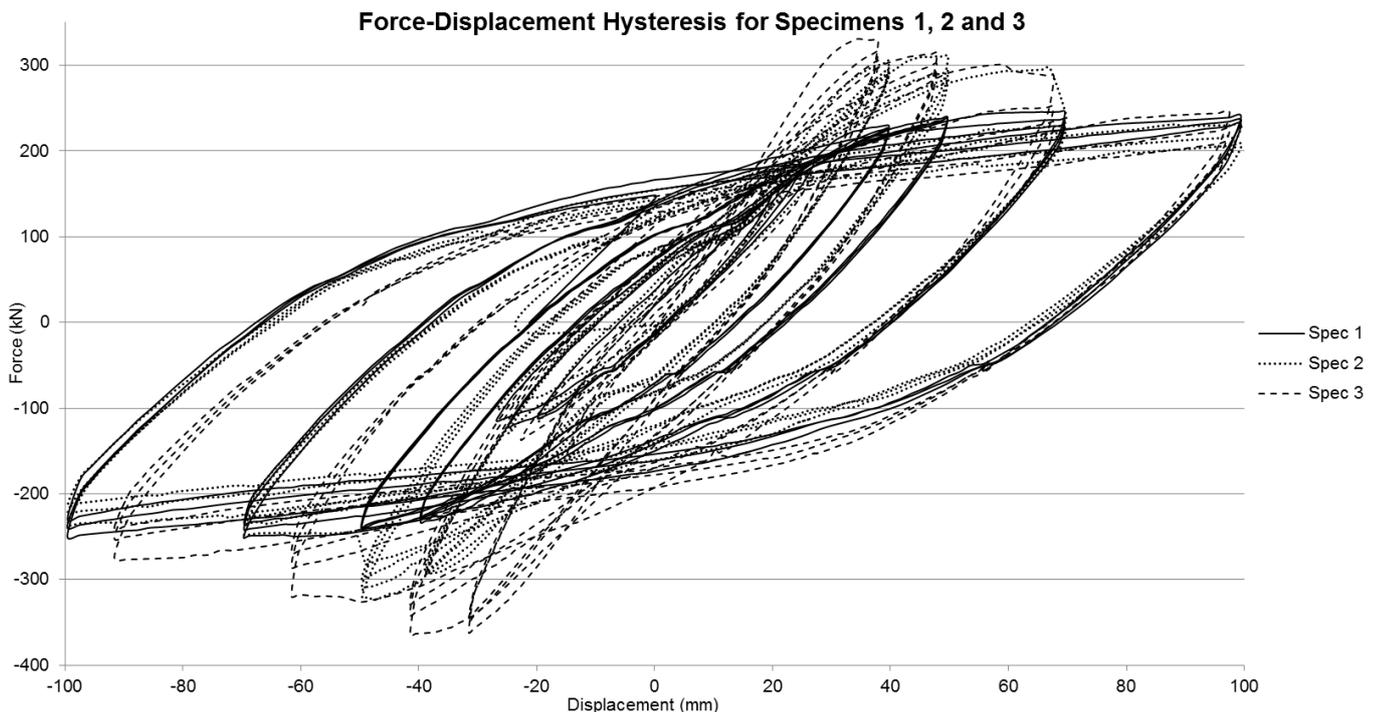
Figure 11: Force-displacement hysteresis for specimens 1, 2 and 3.

Figure 11 shows the hysteresis loops for specimens 1, 2 and 3 from 1% drift to 5% drift. The results of Specimens 1 and 2 are still to be corrected for base plate slip. It may be seen that the peak strengths of Specimens 2 and 3 are increased because of the slab effect compared to Specimen 1. Also, once the shear key locking effect is lost at a drift of 3.5% (70mm), the hysteresis loops become similar.

By comparing the results of Specimens 1 and 2 in Table 2 and Figure 11, we see the effects of separating the slab from the column. As predicted the separation of the slab resulted in a decrease in the strength of the beam-column assembly by approximately 25%. Comparing the maximum strengths it can be seen that at its maximum the slab in contact with the column resulted in a 70kN increase in strength or approximately 140kNm in beam-column joint moment. This strength increase did however come at the expense of ductility. Not only did the beams in the second specimen buckle earlier than in the first but the slab of the second specimen sustained a much higher level of damage. It can be noted however that, once the concrete surrounding the column spalled, the crack widths reduced to the levels of the separated specimen.

Comparing the results of Specimens 2 and 3 in Table 2 and Figure 11, the effect of deck tray direction can be seen. Running the deck longitudinally as done in test 3 allows the full depth slab found in the troughs of the deck tray to be run back into the slab. This gave a 10% increase in strength although this again came at the expense of durability. The slab on specimen 3 sustained significant damage throughout its length which would be difficult to repair without having to replace part of the floor. In this case the use of slab separation seems a sensible option to reduce damage.
