THE BEHAVIOR OF CEILING WITH STEEL FURRING DURING EARTHQUAKES

S. Motoyui¹ and Y. Sato²

ABSTRACT

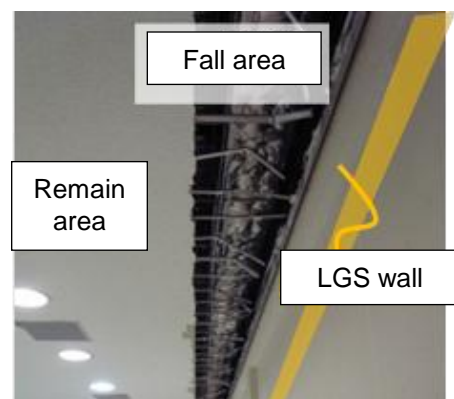
The first example in Photo.1 and 2 is the damage of ceiling boards at the laboratories in Tsukuba. The peak of horizontal ground acceleration was recorded 343cm/sec^2 . As shown in Photo.2, only gypsum boards fell down and steel furring remains original position though it have buckled. At the circumference area of ceiling, the membrane compressive stress is greater than one at other area since an inertia force on the ceiling surface accumulates. Then, the ends of ceiling are easy to suffer damage generally.

Photograph 2 Pattern 1 of ceiling failure

If this result is true, why the Japan style of ceiling smaller than L_{limit} fell down in earthquakes as shown in Photos.1 and 2? It is thought that the cause of ceiling failure is the impact force generates when ceiling surface collides with a surrounding component like a wall. In this section, the spacing between ceiling surface and the surrounding components is supposed to be zero. But, it is impossible to set the spacing to zero and there is always some unavoidable spacing by the gap of construction actually. So, we investigate the relationship between the spacing and the impact force in the next section.

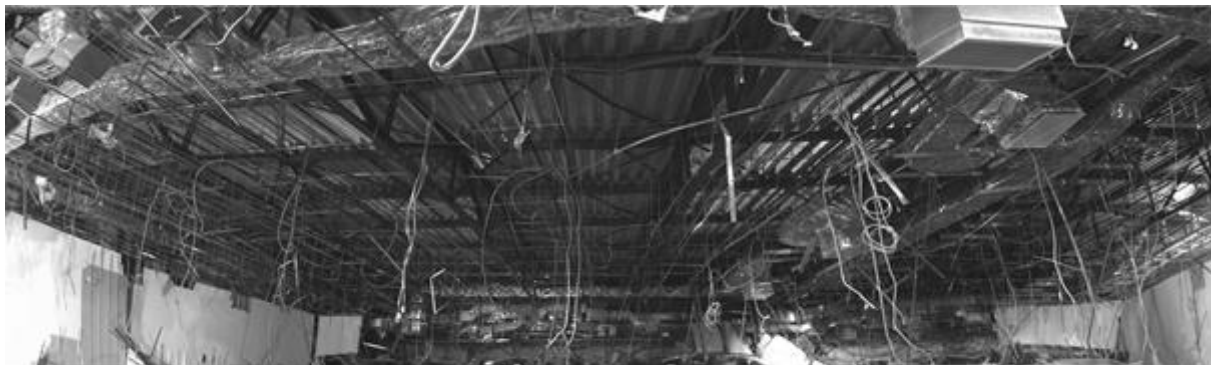
The last example in Photo.4 is the ceiling damage at the top floor of an eight-story building in Yokohama. A few persons were injured. The peak of horizontal ground acceleration was recorded 165gal. The roof of the building is formed by truss beams that cover over 34m span. In this case, there were not spacing. The surrounding wall also suffered serious damage. I guess that the ceiling which had lost counterparts fell down.

Photograph 4 Ceiling failure by combination of Pattern 1 and 2

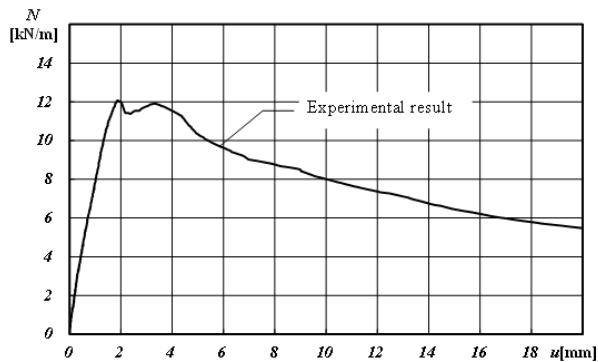
Fig.4 shows the relationships between compressive resultant stress and stretch for the respective direction load. The compressive resultant stress means the compressive force by unit length. According to the results, the maximum compressive strength reaches to about 12kN/m. After the maximum strength, the compressive force decreases immediately. The deformation at the post maximum strength shows in Photo.6. It can be understood that both ceiling surface and hanging bolts buckle.

Figure 4 Compression vs. shortening

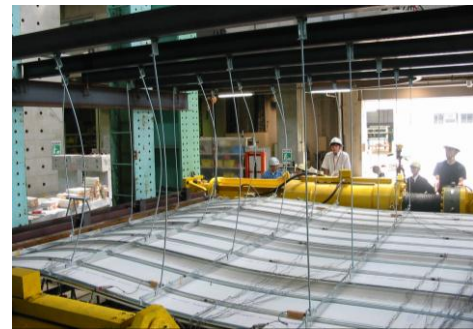
Photograph 6 Deformation after peak

Here, we investigate the unstable behavior of ceiling surface under uniaxial compression force by numerical analysis. To validate a numerical model, we compare the numerical result with the experimental result. See Fig.5 shows the relationship between compressive resultant stress and shortening. The numerical result is close to the experimental one. And the deformation by numerical analysis also agrees with the observed at the experiment (See Photo.6 and Fig.6). Then, the present numerical model can be considered to be appropriate.

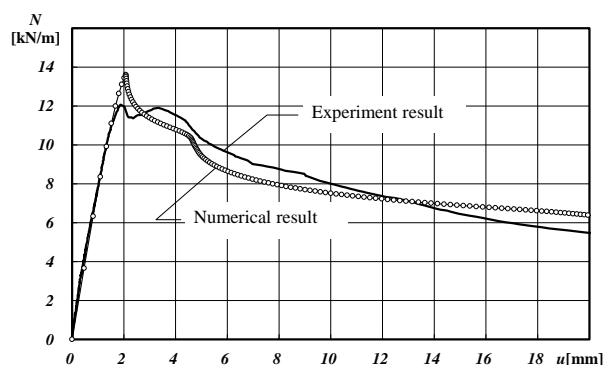
Figure 5 Comparison of numerical and experimental results

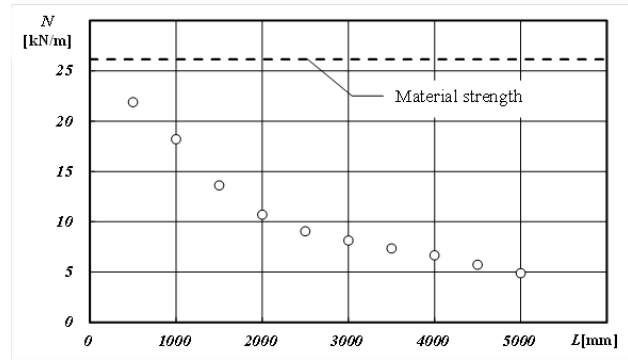
Using the above model, the results obtained by using models with various lengths of bolts are shown in Fig.7. The longer bolts become, the less the compression strengths of ceiling surfaces become. The relationship between compression strength and bolt length is shown in Fig.8. Fig.9 shows the relationship between axial forces on bolts and the shortening of the ceiling surface. By comparing Fig.7 with Fig.9, the maximum compression strengths are determined with the buckling of bolts. Namely, the ceiling surface falls into unstable condition when the bolts buckle. The reason is that the restriction effect of bolts on the out-of-plane deformation of ceiling surface vanishes as soon as bolts buckle. Then, though the longer bolts are sometimes used, a ceiling surface with such bolts is more dangerous than one with the shorter bolts. A lot of engineers think the stress acts on a bolt is tensile and its slenderness ratio is meaningless. However, it is understood that the thought is entirely wrong through the numerical results. The strength of the bolt can be calculated with the formula of Euler's buckling for the pin ended column (Solid line in Fig.10). The compressive strength of 12kN/m for the bolt length of 1,500mm (See Fig.8) is enough to resist the inertia force by an earthquake. For example, supposing the mass per unit area of ceiling surface $[m]$ and response acceleration on ceiling surface $[S_a]$ are 15kg/m^2 and twice of the gravity ($2 \times 9.8\text{m/sec}^2$), the limit of ceiling length L_{limit} can be calculated as following.

Figure 8 Relationship between compression strength of ceiling surface and bolt length
