THERMAL METAL SPRAY FOR BRIDGES: A NEW ZEALAND PERSPECTIVE

Willie L. Mandeno¹

ABSTRACT

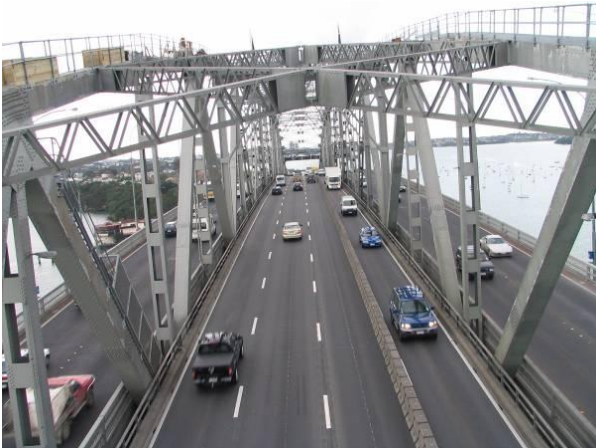
Figure 1. Auckland Harbour Bridge (1958)

The first major application was on the original Auckland Harbour Bridge (Figure 1) when in 1956 its coating specification was amended to the *“best protective treatment known at the time”*, i.e. flame sprayed with zinc at 50 microns and top coated with 3 coats of phenolic paint (Mandeno 1990). Another early and successful application was in 1960 to the roof trusses to the main grandstand at the Ellerslie racecourse in Auckland (Mandeno and Sutherland, 1997). There have been many other applications of TSZ to steel items such oil piping, lighting columns, balcony supports; generally to components that could not be hot-dip galvanized.

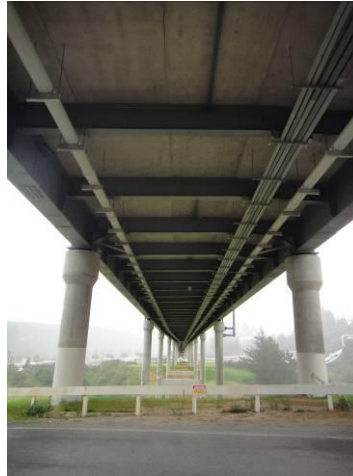
Figure 2. Wairakei Bridge (2010)

Examples of the use of sealed TZA include wharf piles in Lyttleton and a highway bridge over geothermal steam pipelines at Wairakei (Figure 2). Sealed TSZ was used in 1999 to coat large I-beams for the Orewa motorway bridge (Figures 3 & 4) and box girders on the Newlands Interchange Bridge (Figure 5) in Wellington. Very recent applications include; the replacement Kopu Bridge (Figure 6) on State Highway 25 near Thames, the Te Rapa Bypass Rail Overbridge, the replacement Atiamuri Bridge on State Highway 1 that is currently under construction 39km North of Taupo, and Whangarei District Council's Lower Hatea bridge

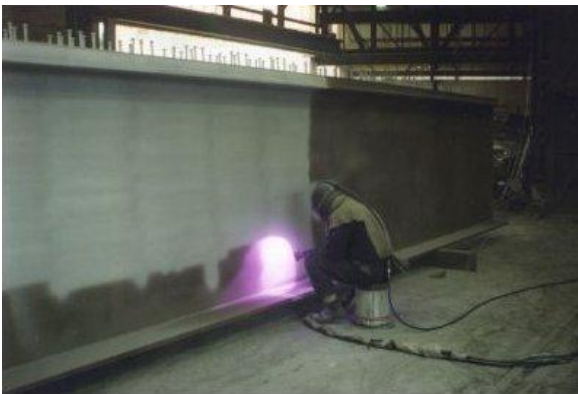
Figure 3. Arc spraying Orewa Bridge Beam

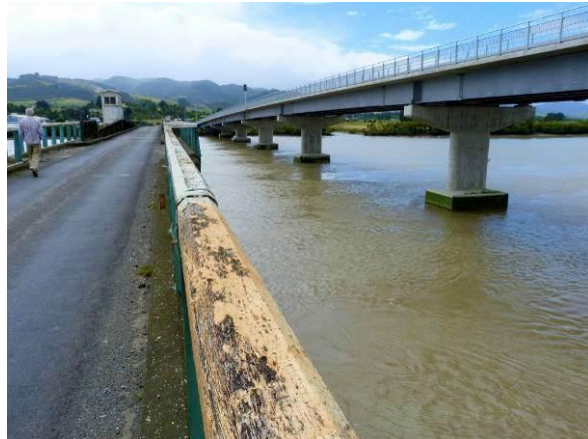
Figure 6. New Kopu Bridge (2011) beside original

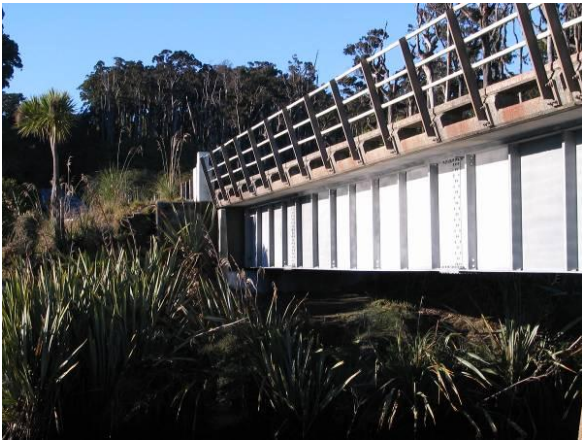
Figure 7. Ship Creek (2003)

(Figure 9). It was also used to maintain in situ RSJ bridge beams over Ship Creek (Figure 7) adjacent to a West Coast surf beach near Haast.

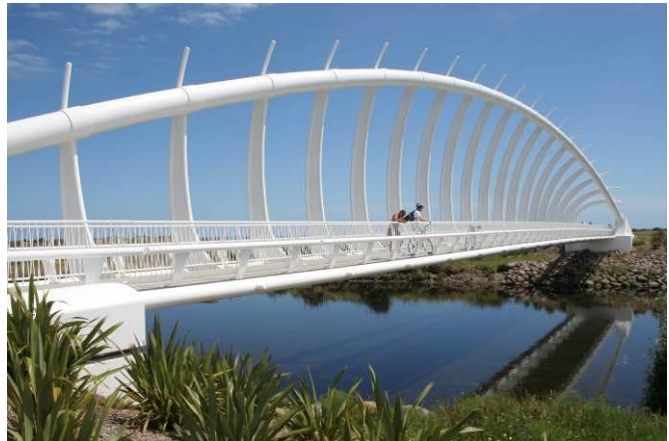
Figure 8. Te Rewa Rewa Footbridge (2010)

Duplex systems (TSZ with epoxy/polyurethane topcoats) have also been applied to several new bridges including the iconic Te Rewa Rewa Footbridge (Figure 8) near New Plymouth, some smaller footbridges such as at Petone Railway Station, and seismic strengthening under the Thorndon Overbridges in Wellington. Some of these and others that had problems are discussed in more detail in a later section.

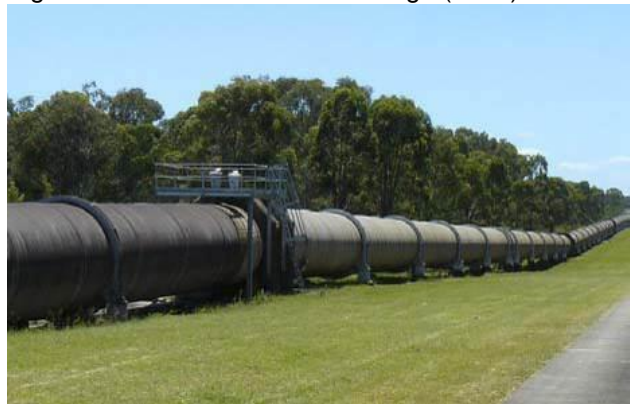
Figure 10. Warragamba Pipeline (P2)

An early and successful use of TSM in Australia was on the second Warragamba pipeline (3m diameter and 22km long) built between 1964 and 1969 (Figure 10). The first had been coated with the same heat-cured zinc silicate invented by Victor Nightingall and first used on the Morgan-Whyalla pipe line. While these have since been repainted several times, this has been due to delamination of the various overcoating systems and the underlying flame-sprayed TSZ is still sound (Salome 2012). These pipelines supply 80% of Sydney's water supply.

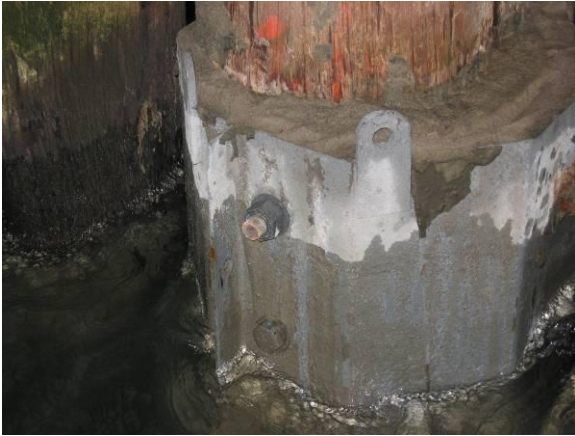
Figure 11. TSA on pile jacket

TSA has been used since 2005 to protect structural steel used as beams and jackets to strengthen old timber wharves owned by the Lyttleton Port Company (LPC) and this has performed well where correctly applied (Figure 11).

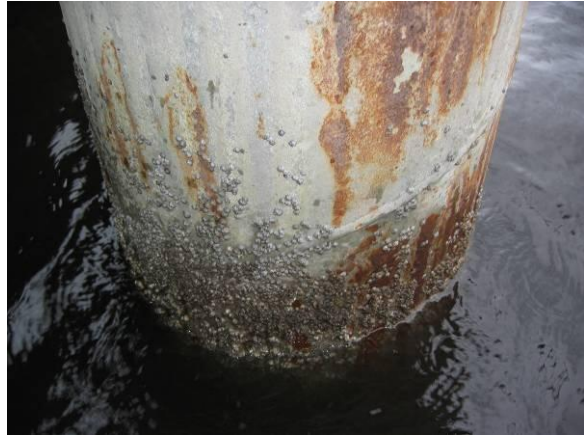
Figure 12. TSA "failure" on pile

In 2008 the author was asked to investigate premature failure of TSA coating on a new coal loading berth at the Lyttleton Port. As shown in Figure 12, the aluminium coating had disappeared in the tidal zone on most of the piles; some were more severely affected than others. The piles were designed with a sealed TSA coating to protect them above the low tide level, and below this as bare steel protected with sacrificial anodes. Inspection by divers found that the installed anodes were both undersized for the area they were required to protect and that some had become disconnected during driving. The TSA was therefore acting as a sacrificial anode and the protection system had to be replaced by a petrolatum wrap and HDPE jacket, plus bigger capacity anodes were retrofitted to the piles to protect the uncoated surfaces.

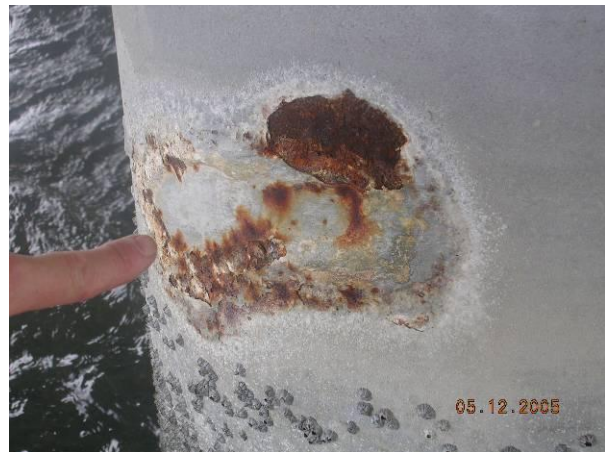
Figure 14. Failure of TSA repair?

An expressway near Napier Airport includes a bridge structure over the Ahuriri Lagoon. The steel jackets to its concrete piles were coated with 325 microns of sealed aluminium (TSA325S) in 2003. A few years later roughly circular rust patches approx. 100 to 200mm in diameter appeared in random locations below high tide level as shown in Figure 14. Its failure is currently under investigation with unsuitable repair methods (patching areas of low build with ultrahigh-build epoxy) being suspected as being responsible.

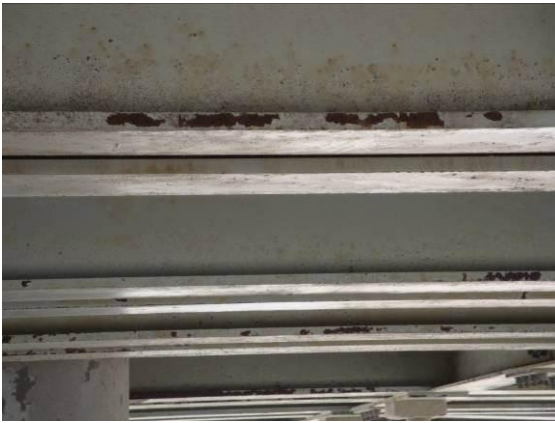
Figure 15. Duplex TSZ failure on a TOB catch frame

The seal coating is delaminating from the upper levels of the pier jackets where windborne marine salts are not removed by rain washing (Figure 16) but no corrosion of the steel jackets has been observed. However red rusting has occurred on the catch frame steelwork which has recently been recoated but with an additional 200 micron epoxy intermediate coat added to the system over an epoxy-zinc patch primer. The corrosion was due to delamination of the duplex TSZ from flange edges of the fabricated I-beams and also pitting occurs where peaks of the zinc had inadequate barrier protection from the epoxy urethane (Figure 15).

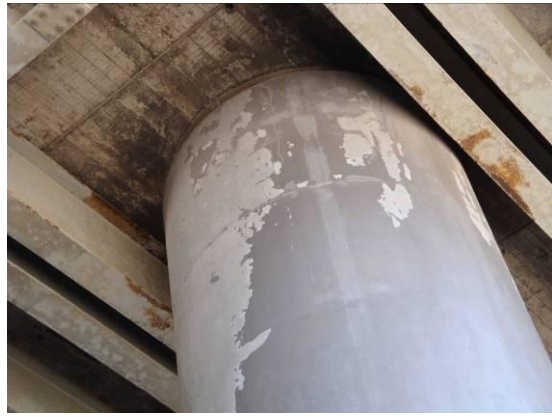
Figure 16. Seal coat delaminating off TSZ

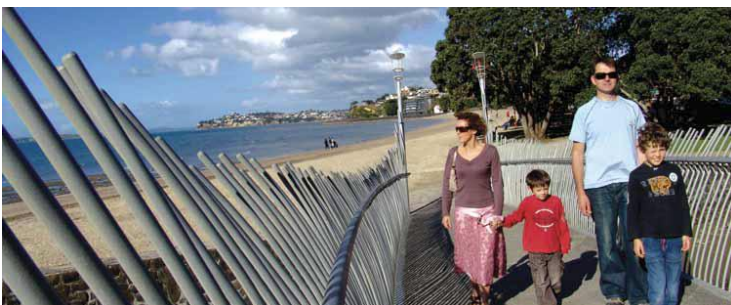
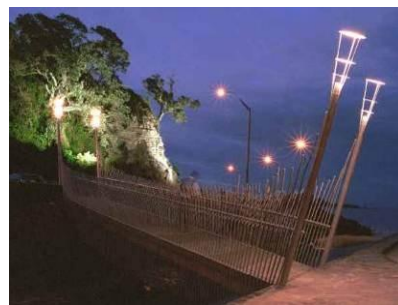
Figure 19. Millennium Footbridge

Figure 20. Millennium Footbridge

Built as part of a waterfront walkway near Mission Bay, Auckland in 2001 (Figures 19 & 20), and designed by artist Virginia King, this had tubular steelwork that was coated with an unknown thickness of TSZ. The Galvanizing Association of New Zealand has reported (GANZ 2010) that this failed prematurely and in 2009 the flaking TSZ was removed and replaced with a duplex galvanizing/paint system at a cost of NZ\$70,000.

The surface profile of the steel substrate being sprayed is also important to ensure adequate adhesion. A very clean surface with a sharp angular profile of at least 50 microns is required for TSZ, and at least 75 microns for TZA. This may not be achieved on the flame cut edges of flanges on fabricated plate girders, unless the local surface hardening at gas-cut edges are removed by grinding prior to abrasive blasting. Sections cleaned using shot in a centrifugal blaster such as a Wheelabrator, will require a final blast with grit to achieve a suitable profile shape. The author has investigated delamination of TSZ from a local pier handrail where the surface profile was measured at <30 microns. A low surface profile may also have been the cause for the premature failure of TSZ on the Millennium Footbridge.

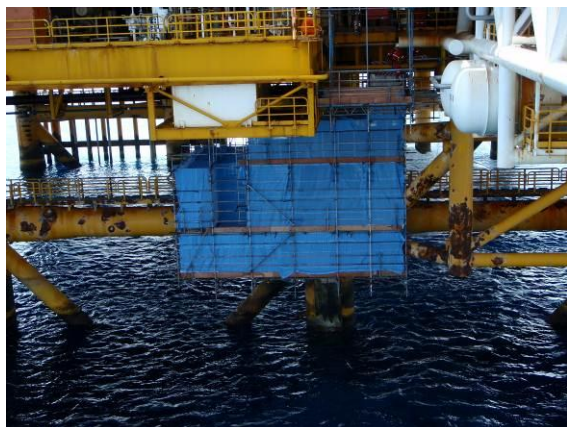
Figure 19. Gas platform maintenance painting

The duplex TSA coating on this platform in the Timor Sea began failing within a year of its construction and is currently undergoing extensive maintenance painting. Similar problems have been found on North Sea platforms where the performance of duplex TSA has been inferior to the excellent performance of more usual sealed TSA. This was investigated by SINTEF (Knudsen 1997) and failure is attributed to the formation of hydrochloric acid from hydrolysis of unstable aluminium chloride trapped under the thick organic coating.

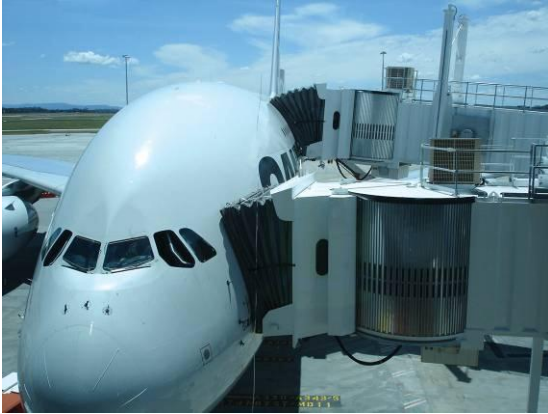
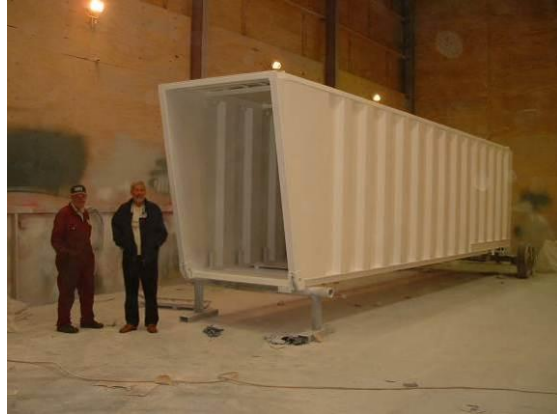
Figure 21. A380 loading in Sydney

Figure 22. Duplex TSZ applied in NZ

SINTEF also reported that duplex TSZ had performed well on several road bridges in Norway where four coats of paint were applied over TZS100. A duplex TSZ system has been used successfully on New Zealand made air-bridges that have been supplied to several airports around Australasia (Figures 21 & 22). The future performance of the duplex coatings on the Te Rewa Rewa and similar bridges will be monitored with some interest.
