# STEEL DELIVERS EARTHQUAKE RESILIENCE

KiwiRail's maintenance facilities are a crucial part of the national rail network. Its Woburn site in Lower Hutt is home to several expansive warehouses. KiwiRail is progressively improving the safety and efficiency of these assets, which include workshop building upgrades and seismic strengthening.

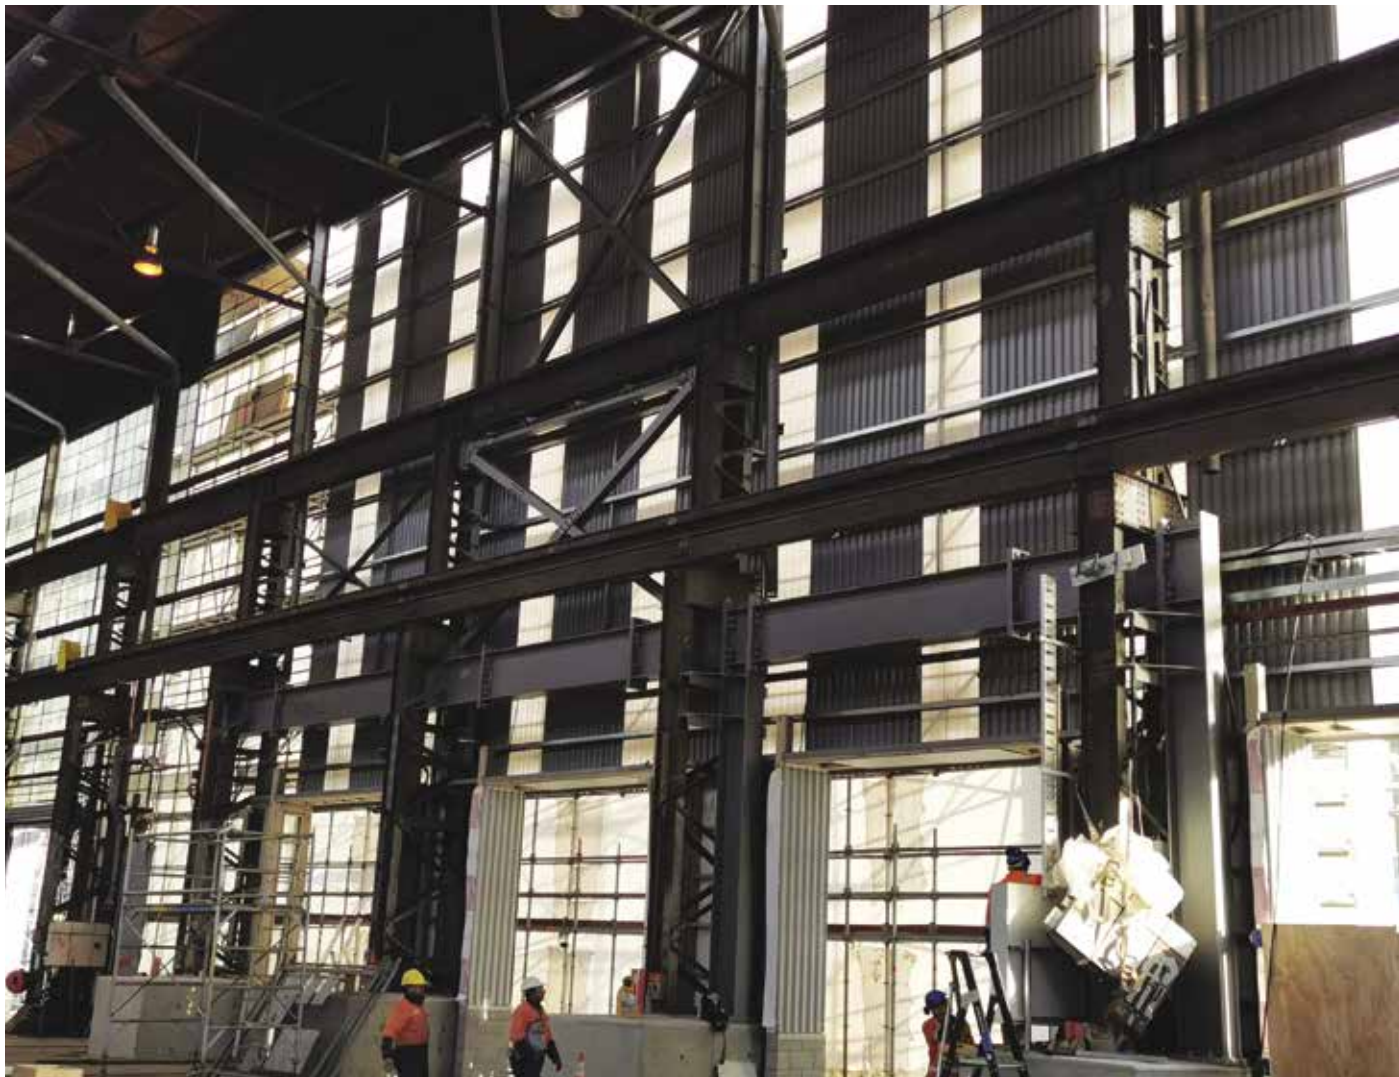
IN ALL, THERE ARE SIX MOMENT-RESISTING FRAMES CONSISTING OF FOUR COLUMNS EACH WITH A BEAM IN BETWEEN.

There were 27 roller doors along the length of one face for the trains to enter and exit for maintenance purposes. A more conventional cross-bracing solution extending down to floor level was completely incompatible with the use of the building as it would block the doorways that trains have to pass through. Instead, the solution involved installing large custom-welded beam portals to carry the load – a good example of steel's intrinsic design flexibility. In all, there were six moment-resisting frames consisting of four columns each with a beam in between.

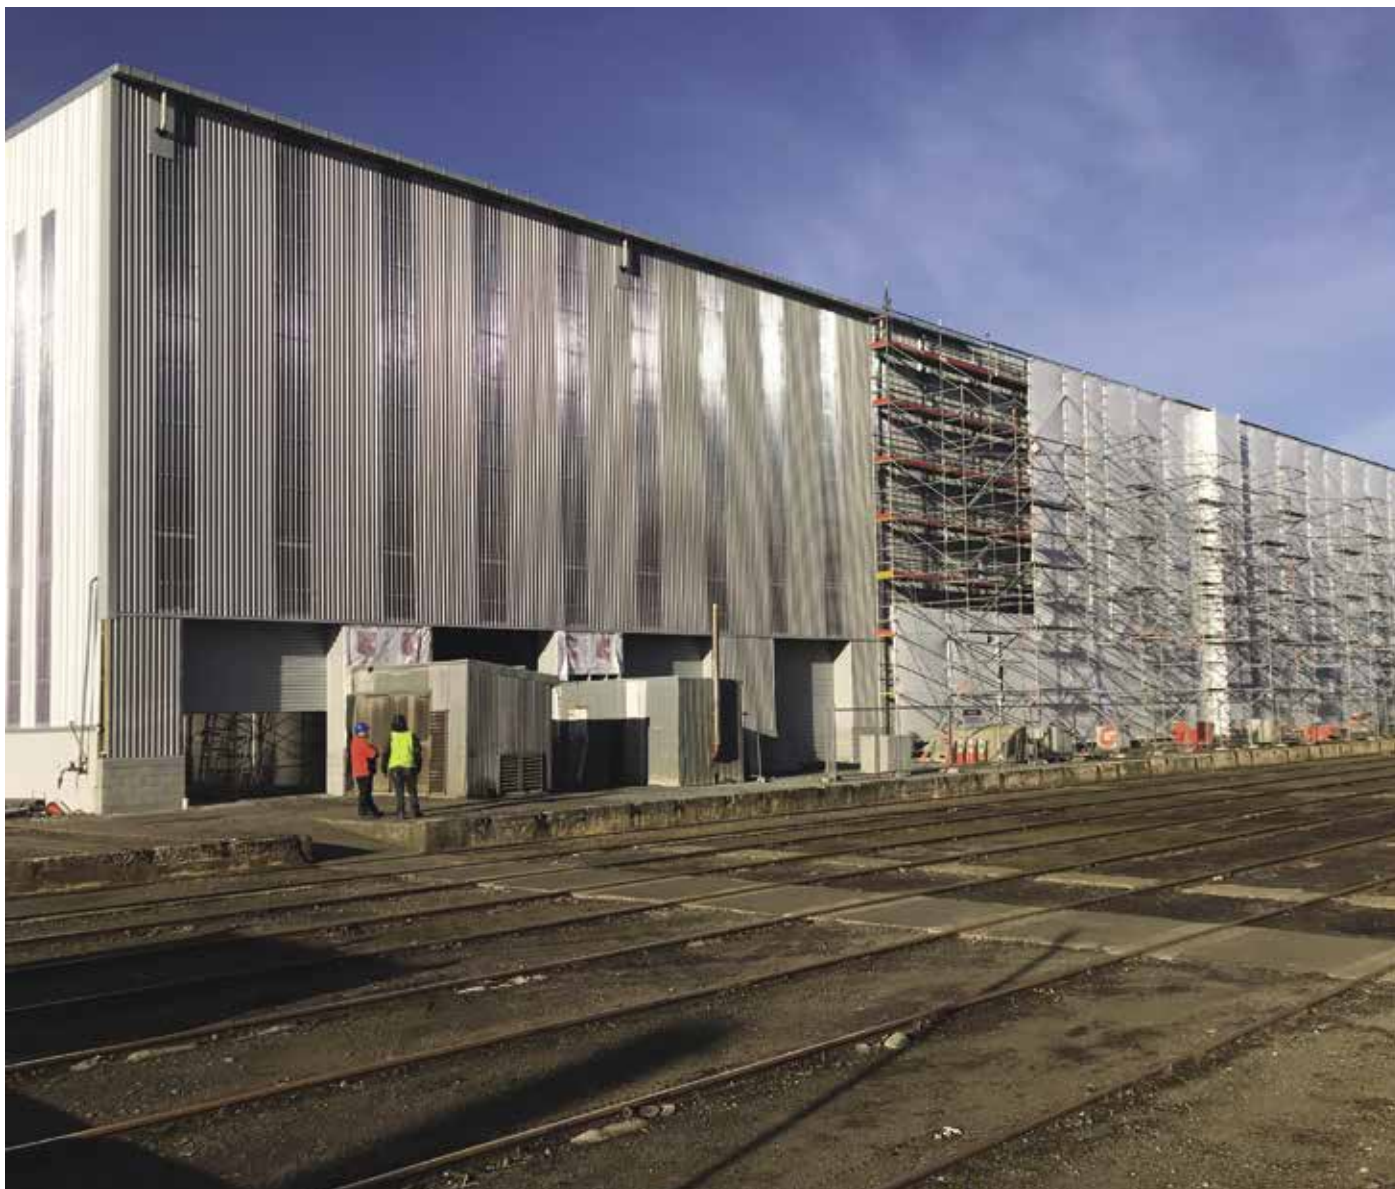
Once the cladding was removed, the steel was wet blasted to allow the engineer to easily inspect all of the steelwork and identify what remediation may be required. The majority of the steel structure was in very good condition but column base plates along one grid line that had been exposed to weather were rusting. To address this localised area of corrosion, the base plates were encased in concrete.
