# STEEL ENABLES ICONIC CATHEDRAL REINSTATEMENT

Christ Church Cathedral suffered extensive damage as a result of the devastating Canterbury earthquakes of 2011. In 2017, the decision was made to reinstate the Cathedral, an iconic Christchurch landmark and Category 1 listed heritage building. In 2019, the project team was appointed.

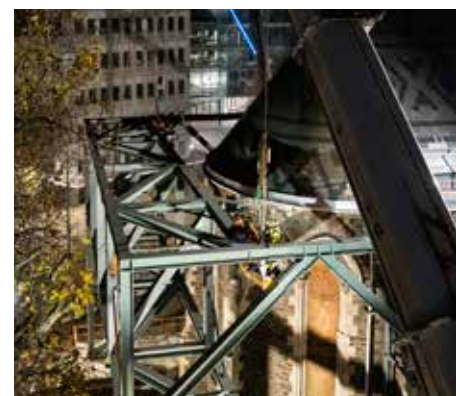
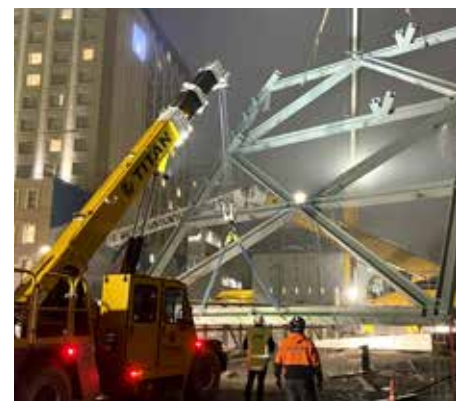
RIGHT, TOP AND BOTTOM: STEEL PROPPING AND BRACING ELEMENTS BEING INSTALLED.

On the building's exterior there are several steel structures to prop and brace elements until it is strengthened. Physical works began in 2020, starting with demolition of the visitors' centre, and north and south vestries. Other major work fronts are the west end, south transept and north porch, followed by the north transept, side aisle walls, roof, apse and the crossing, and the interior clean up. The partial deconstruction of some badly damaged sections is required to make safe, manage collapse hazards and allow a more efficient strengthening phase.

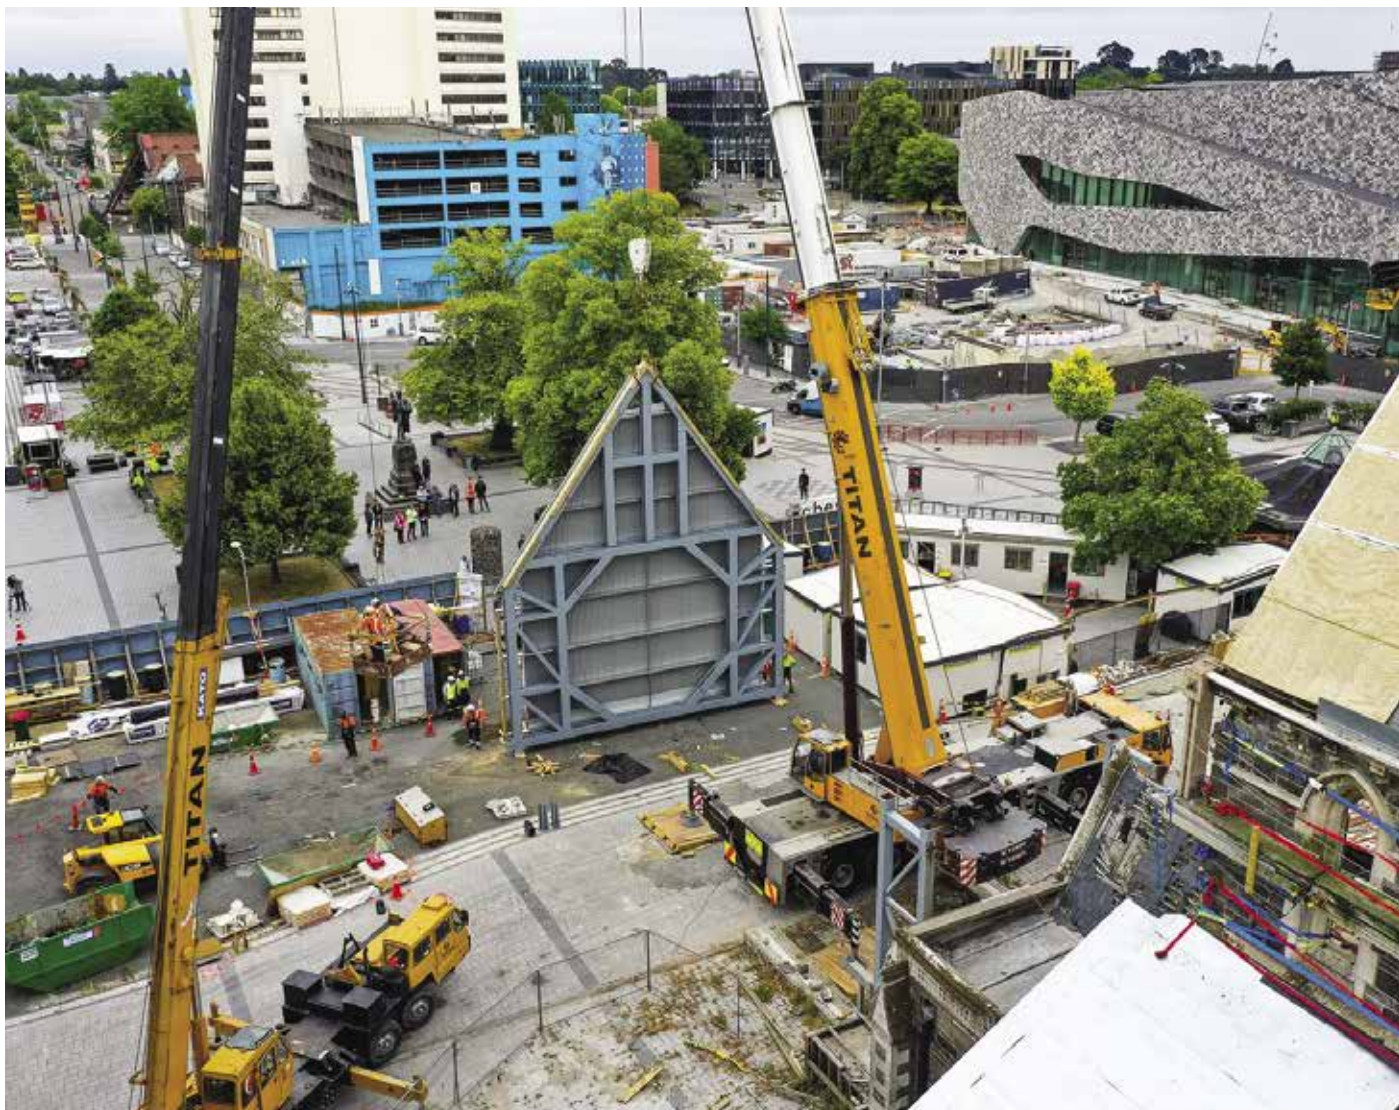
ABOVE: SOME OF THE STABILISATION STEELWORK WILL BECOME PERMANENT, INCLUDING THE STEEL SURROUNDING THE ROSE WINDOW IN THE WEST WALL

Some of the stabilisation steelwork will become permanent, including the steel surrounding the rose window in the west wall. It was the first frame and the first permanent structure

installed. Warren and Mahoney set the parameters for positioning the frame, which will eventually be concealed between two stone wall veneers. So, the former 1,200mm-thick, unreinforced masonry wall will be reinstated as a composite steel-masonry wall - it will look exactly the same but it will be stronger and lighter.

The west wall is one of just a few sections of steel that will be permanent. It has a steel plate fixed to the frame with the installation date as it is reported in the heritage documentation. Steel's light weight means that, once the frames are clad in heritage stonework as part of

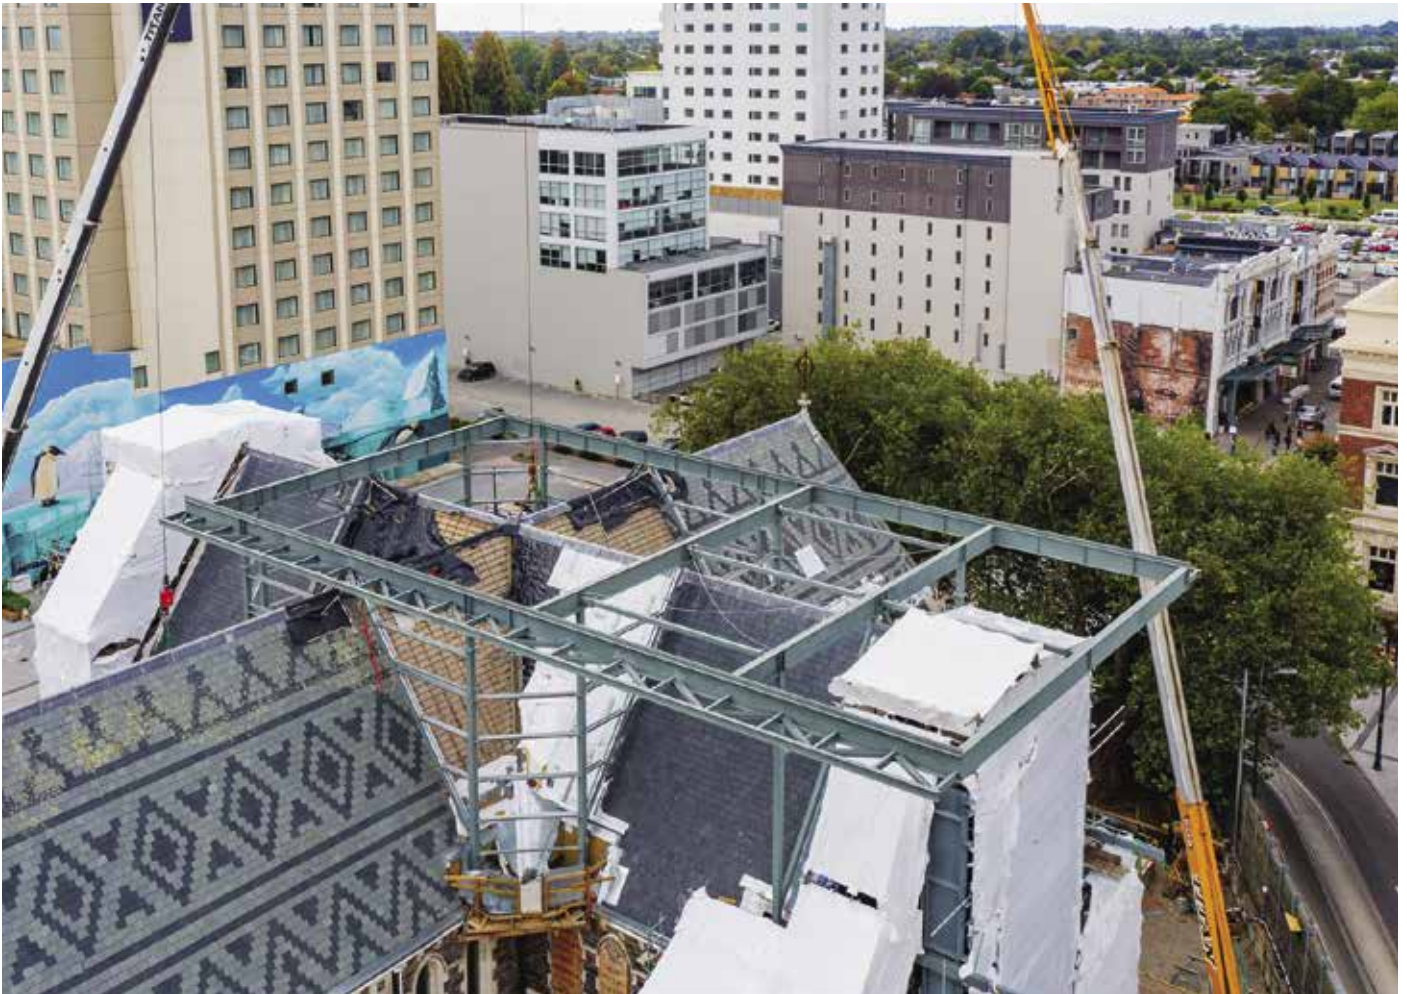
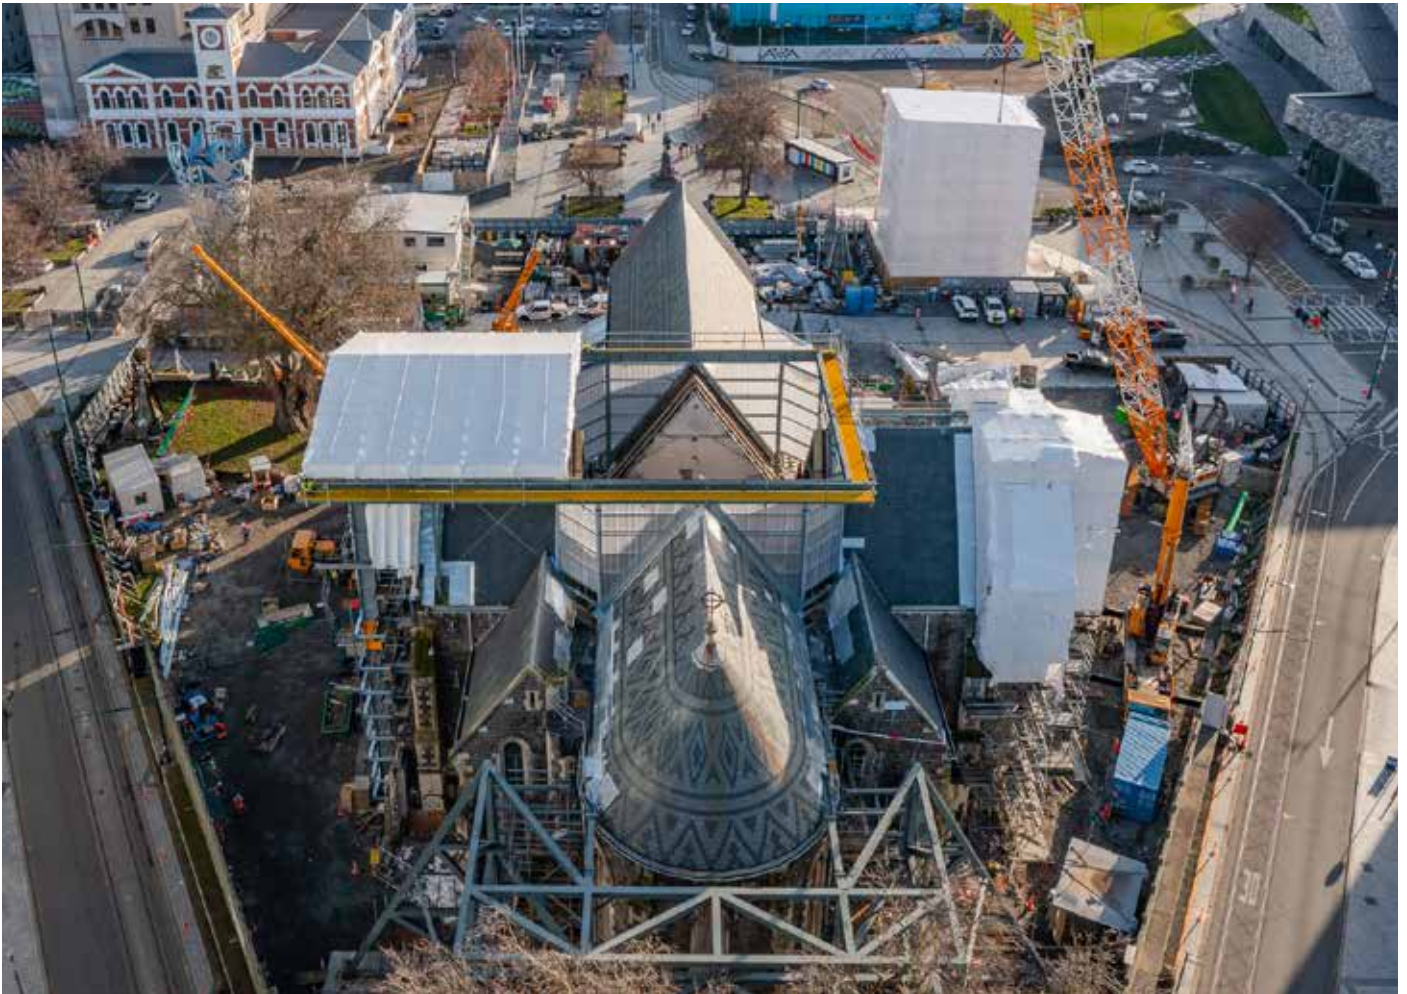
OPPOSITE PAGE AND ABOVE: ONE INNOVATION ON SITE IS THE TEMPORARY SLIDING ROOF OVER THE CROSSING. IT PROTECTS THE HISTORICAL FEATURES WITHIN FROM THE ELEMENTS AND ALLOWS WORKERS SUSPENDED IN A CAGE ON A CRANE TO BE LOWERED THROUGH THE OPENING INTO THE HEART OF THE BUILDING.

One innovation on site is the temporary sliding roof over the crossing. It protects the historical features within the crossing from the elements while still allowing stonemasons to deconstruct the heavy gable arches in line with the site's safety protocols and stabilise the specific work front. The assembly includes a plastic sheet over the top of a scaffold frame that slides open

and closed on steel rollers and large steel upright connections into each of the crossing corners. Suspended in a cage on a crane, workers can be dropped down through the opening into the very heart of the building. A uniquely steel solution.

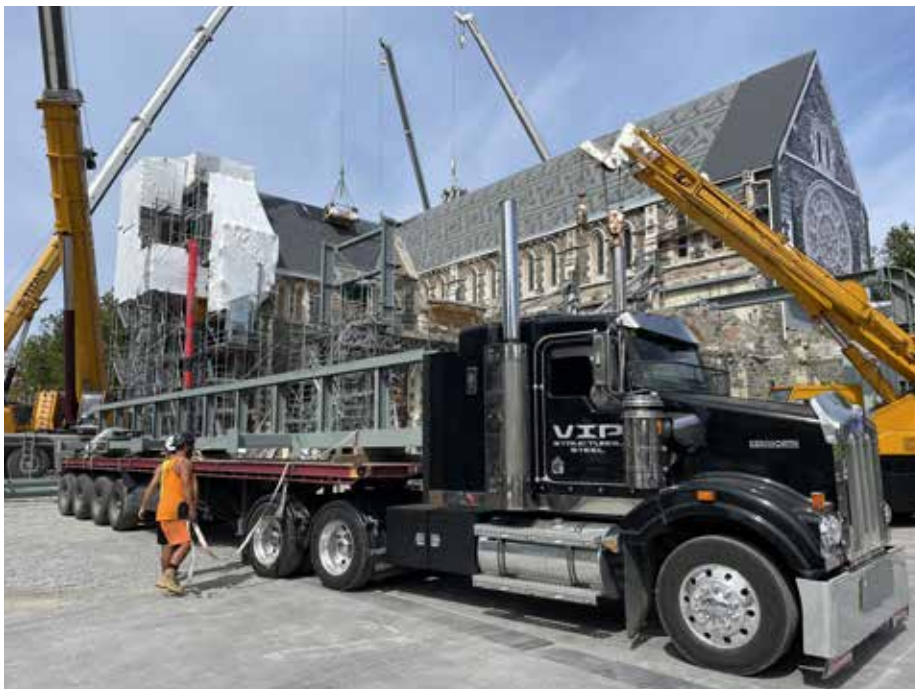
LEFT: THE COORDINATION REQUIRED TO HAVE THE STEEL DELIVERED, ASSEMBLED AND INSTALLED ON SITE HAS BEEN INTENSE. IT TAKES MONTHS OF PLANNING TO LIFT A SINGLE FRAME INTO PLACE.

The coordination required to have the steel delivered, assembled and installed on site has been intense. It takes months of planning to lift a
