# WESTGATE FOOTBRIDGE, AUCKLAND

# John. McNeil<sup>1</sup> and Dr. Oliver de Lautour<sup>2</sup>

The paper presents the background to the project, the use of steel and the key issues associated with the design and construction of the project.

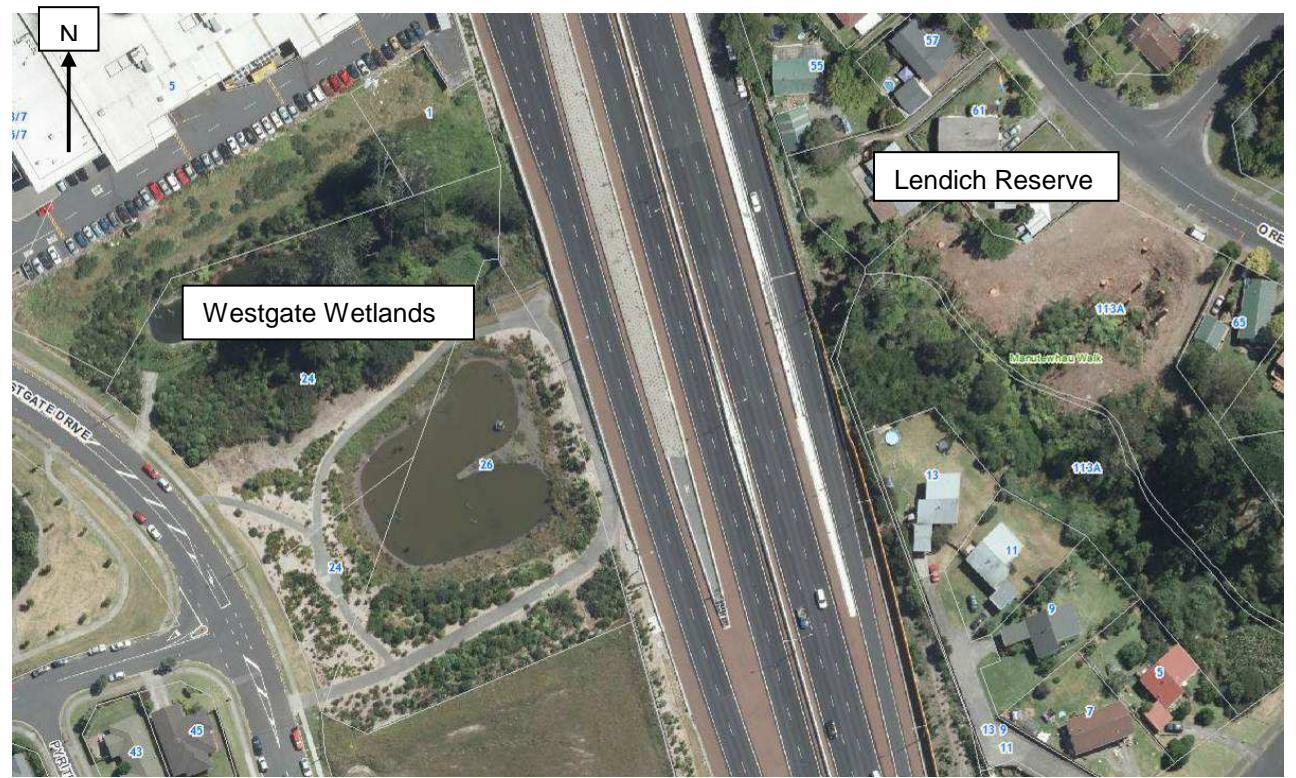
Figure 1. Site location – Source Auckland Council Maps.

An aerial photograph of the site location is given in Fig. 1. The proposed bridge was required to be within the current SH16/18 designation and council park land, that is Westgate Wetlands (to the right of the figure) and Lendich Reserve (to the left of the figure).

Lendich Reserve is located approximately 6m below the SH16 carriageway. The reserve consisted of large pine trees with dense over growth surrounding a steep bank down to a creek. There are a number of houses located around the perimeter of the reserve. Fig. 1 shows the park after the site was cleared of large tree for construction.

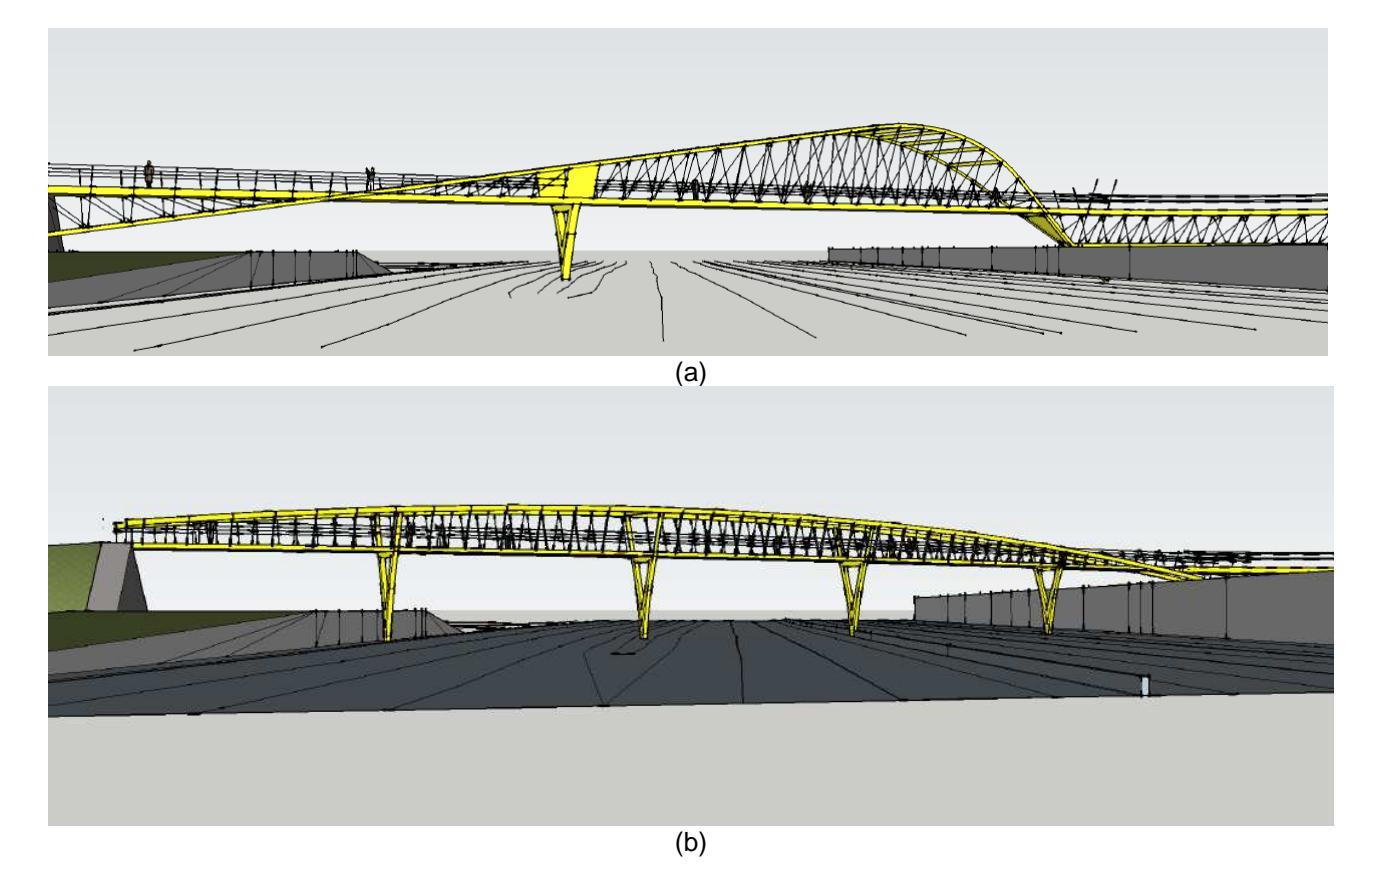
Figure 2. Early concepts across the carriageway (a) large span arch (b) truss with spans between carriageways.

the carriageway (through structure) and having unobstructed views over the reserve (structure underneath), see Fig 2a. However, these large span concepts were considered to be too difficult from a constructability perspective and where also a bold statement visually that was not suited to the site. It was decided that piers should be placed between each carriageway to limit the span lengths and weights for construction, see Fig 2b. The transitioned top and bottom chords were simplified into two separate bridges.

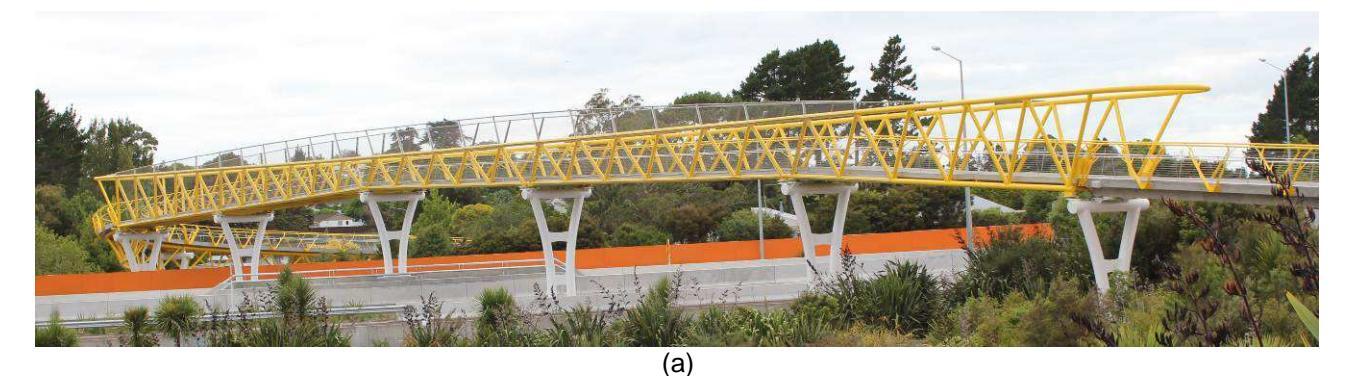
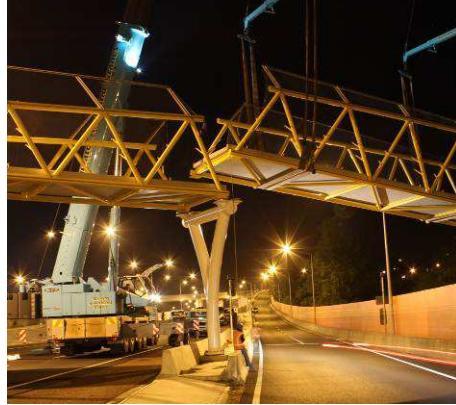
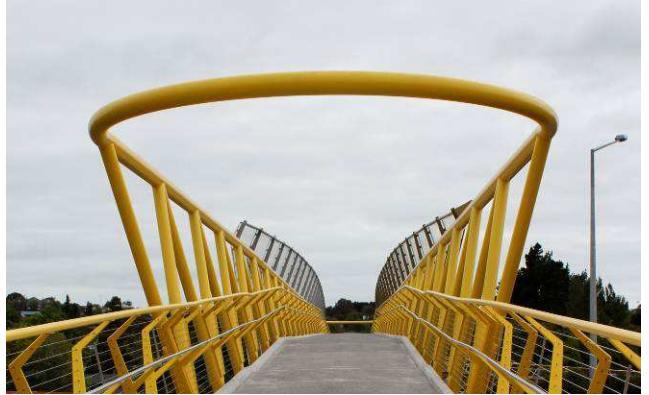
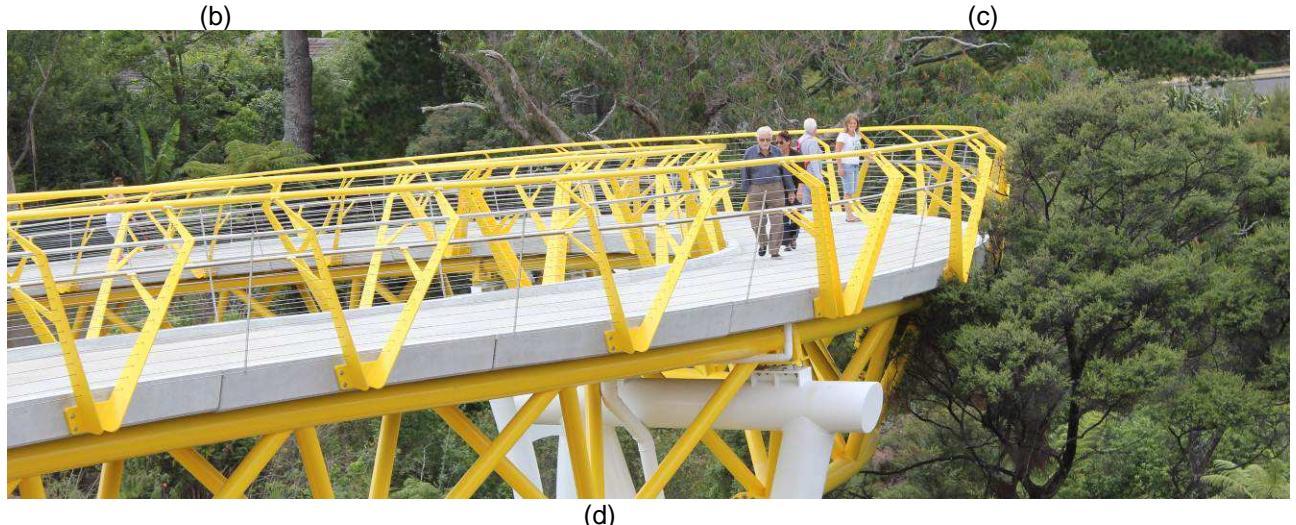
Figure 3. (a) Bridge 1 over the carriageway (b) twisted pier and in-fill piece (c) sloped truss webs and throw screens (d) handrails.

The chosen concept across the carriageway is shown in Fig 3a and b. The concept has the minimum structural depth at the central pier across the carriageway and the bottom chord follows the vertical alignment requirements to achieve both vertical clearance and gradients. The spans vary in length between approximately 16 - 20m. The top chord forms a straight line between the central pier and is at a gradient to achieve equal heights at the ends of the truss. The shape creates an optical illusion of a sagging top chord. For ease of construction the spans were simply supported, however, to achieve the visual effect in the shape a continuous chord was required. To respect the form of structural action, an in-fill piece distinct from the top chord was used between the spans, see Fig 3b. To keep the sense of space across the footbridge the truss diagonals were sloped at 1:5 outwards, see Fig 3c, initially a slope of 1:3 was considered. This also creates a visual feature with the top chord moving inwards/outwards with the dimension between the top chord

decreasing and increasing. Late in the detailed design phase the addition of throw screens over the carriageway was requested. After investigating several options a concept was developed that accentuated the shape of the truss and the sloping sides, see Fig 3c. The throw screen mesh was made from stainless steel wires. The alignment of the bridge to the carriageway was skewed and to keep the ends of the truss square a skewed support was required. A twisted V-pier was developed and was considered to be an interesting feature of the bridge that related to its alignment, see Fig 3b.

To keep with the triangular form of the truss, the concept for the handrail post was developed in which equal spacing between the handrail supports was achieved with angled twin posts, see Fig 3d. Stainless steel wires at 80mm crs vertically were used for in-fill and stiffened double plate handrail posts were provided at the tensioning locations for the wires. A top rail at 1400mm and lower rail at 900mm was provided for cyclists and pedestrian respectively. LED Puck lighting was provided in the lower handrail to illuminate the deck.

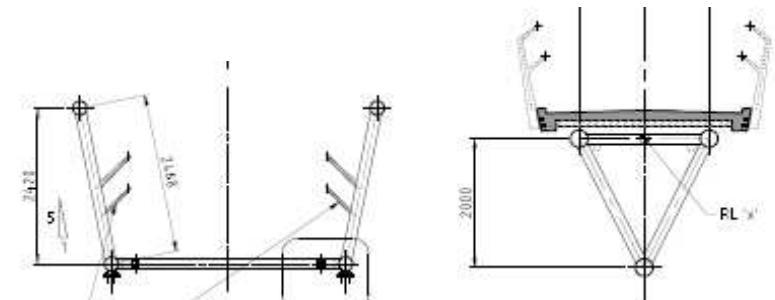
Figure 4. Cross section of trusses, bridge 1 (left) and bridge 2 (right)

Two different trusses were used in the design with a through truss for Spans 2-5 (Bridge 1) across the carriageway and an underslung truss for Spans 6-11 (Bridge 2) over the reserve, see Fig. 4. Both trusses were constructed from Grade 350 steel CHS sections that were shop welded. The truss nodding was detailed for zero eccentricity at the joints and the joint capacity was evaluated using the guidance in CIDECT design guidance (CIDECT, 1995). Tension/compression bracing was provided at the bottom and top chord levels of bridge 1 and 2 respectively.

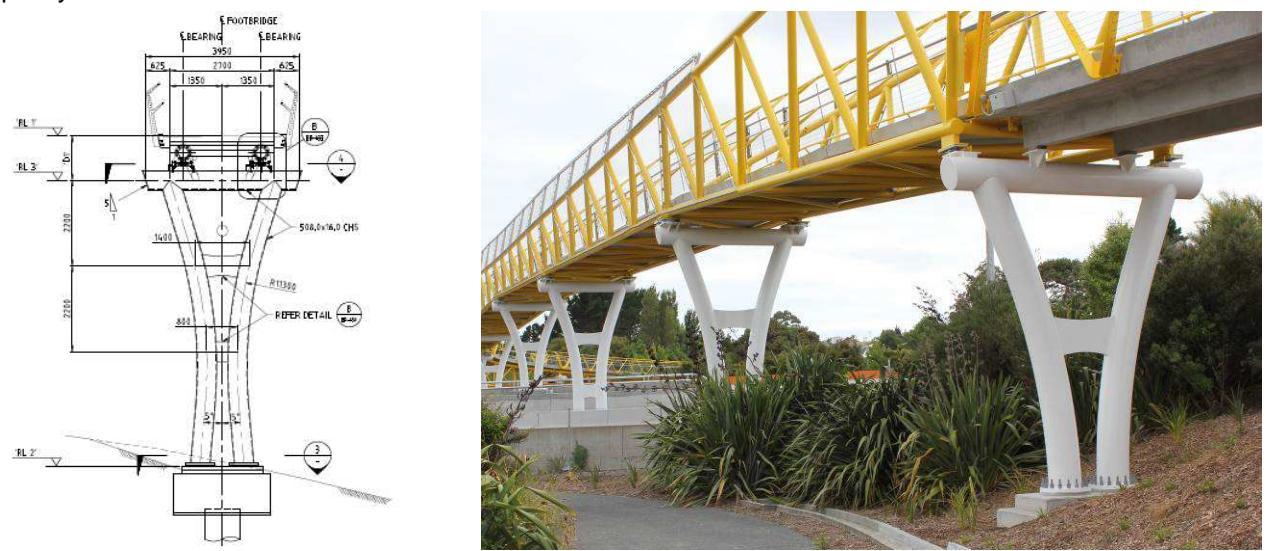
Figure 5. Typcial pier arrangement.

The piers were constructed from Grade 350 steel sections. The piers where designed as twin curved columns with a transverse member connecting the tops, see Fig. 5. Bracing was provided to resolved forces due to the changes in inclination of the columns. Piers 2 -5 which were located in the carriageway were twisted. As the CHS sections can only be bent in one direction the shape was achieved by inclining the pier to the vertical. The piers were detailed for future bearing replacement with jacking locations provided.

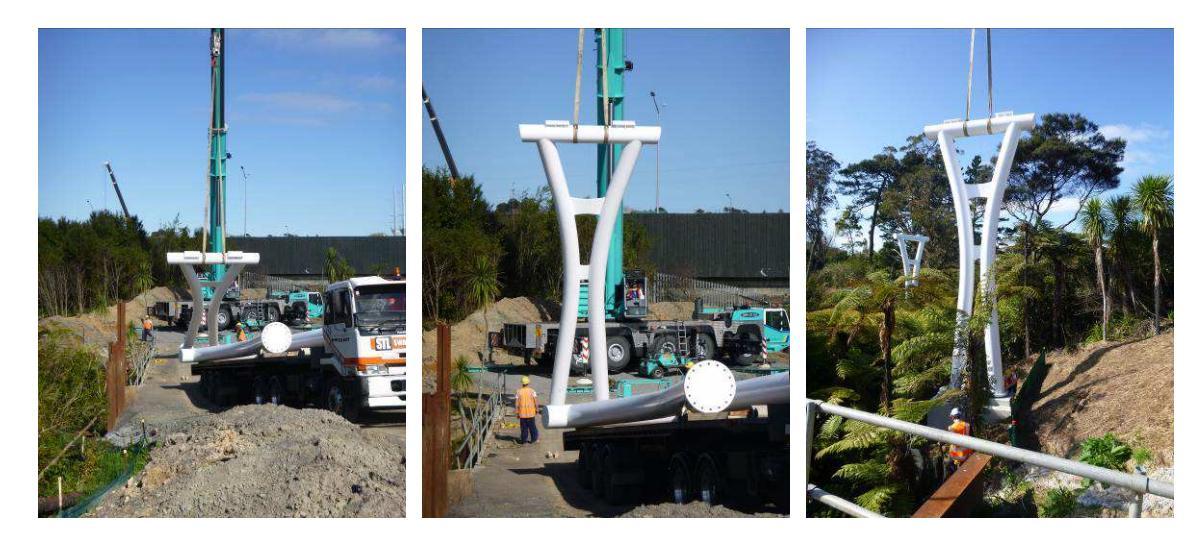
Figure 6. Pier 8 erection.

The bridge 2 piers, Piers 6-10 were erected first. The piers were transported to site by truck and lifted into place with using a 150T mobile crane, see Fig. 6. The piers where landed onto leveling nuts and the base plate was grouted afterwards. The piers were approximately 5.5 to 6.5T each and Pier 9 was lifted with at a 41.5m radius. Piers 1-5 in the carriageway were erected during night closures.

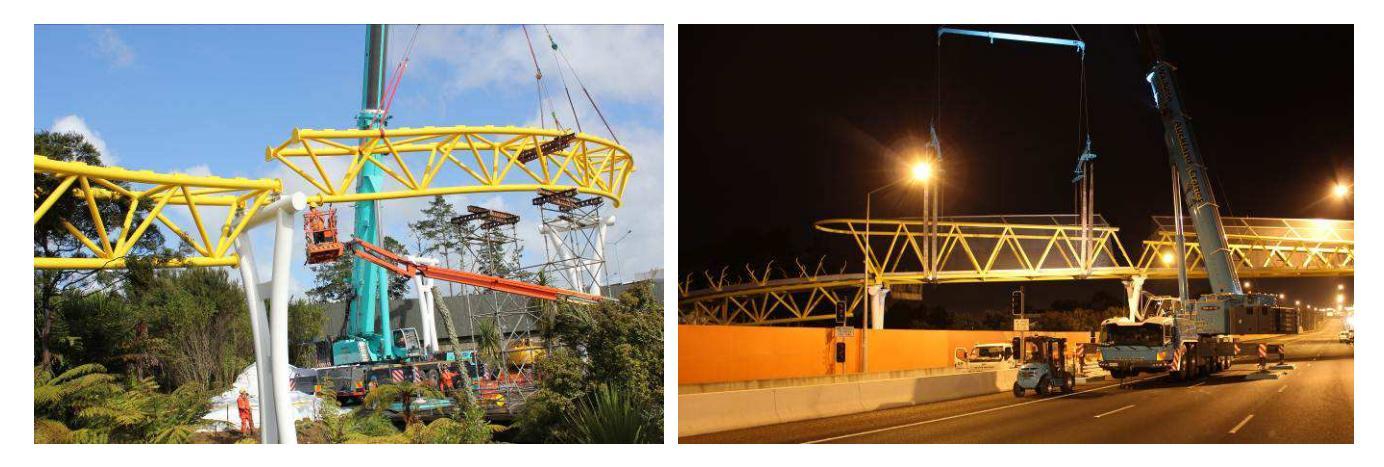
Figure 7. Bridge 2 span 8 lift (left), Span 6 being lifted into place.

The truss spans were lifted in to place using a 200T mobile crane without the precast deck. Fig. 7 shows all spans in place with the temporary propping installed. Erection of the spans took approximately 5 days with site drilling of some of the bolt holes require to provide tolerance.

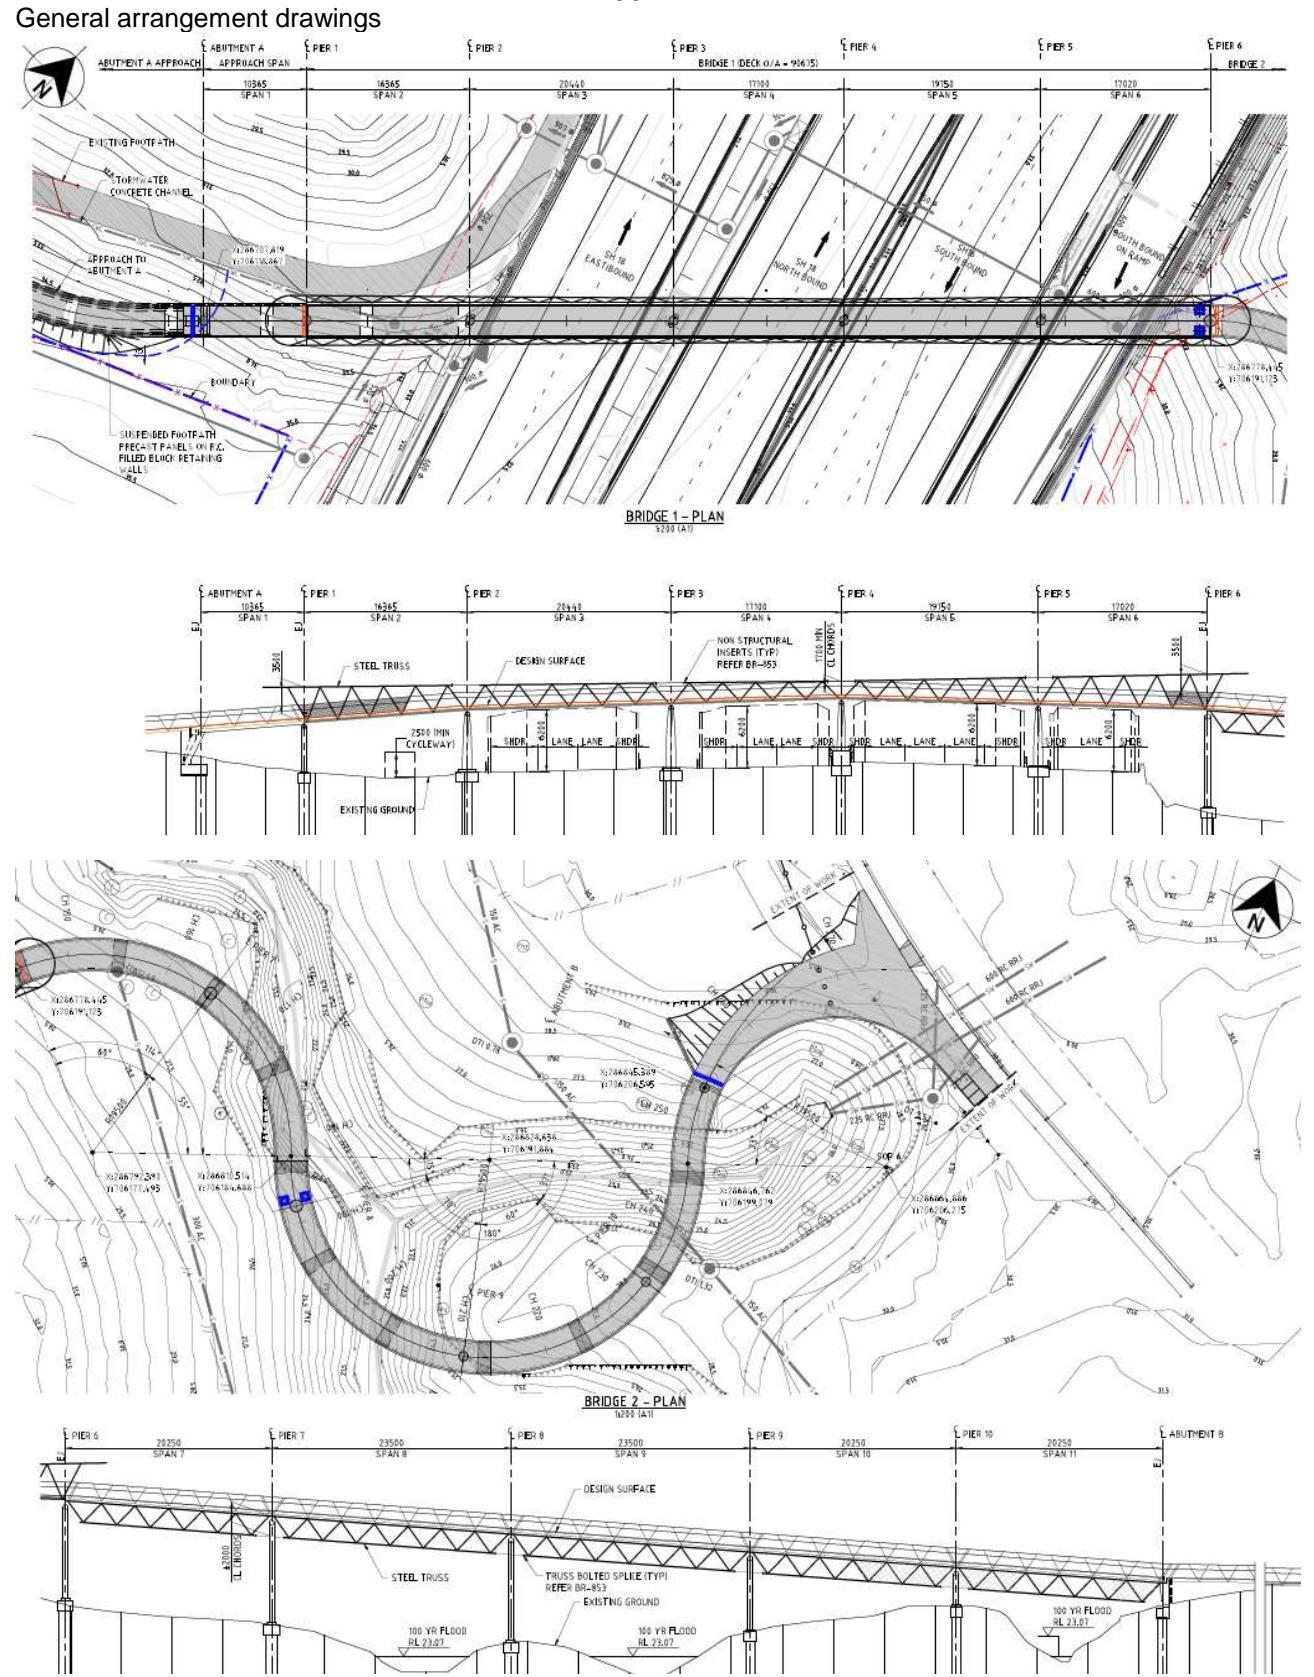
### Appendix

The preferred concept was developed and detailed to produce drawings for construction. Design of the bridge was in accordance with Transit New Zealand Bridge Manual (TNZBM, 2003). General arrangement drawings for reference are included in the appendix. The key design challenges were;
